CITY OF ELK GROVE

Facilities

Access Compliance Assessment Report

June 2018

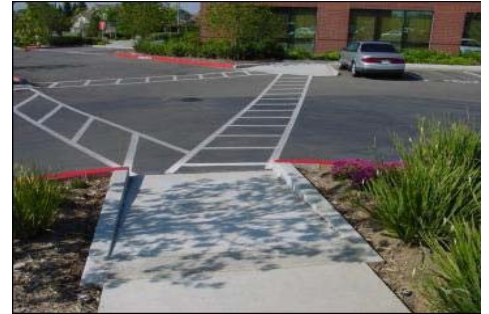
- *Original Problem Description:*
Each concrete curb ramp located at the triangular crosswalk between the facilities does not provide a detectable warning surface which includes truncated domes.

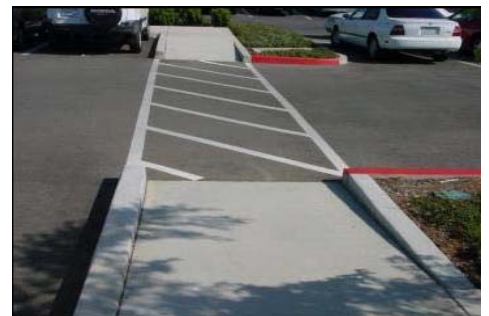
- *Original Problem Description:*
Each concrete curb ramp south of city hall in the center of the parking lot does not provide a detectable warning surface which includes truncated domes.

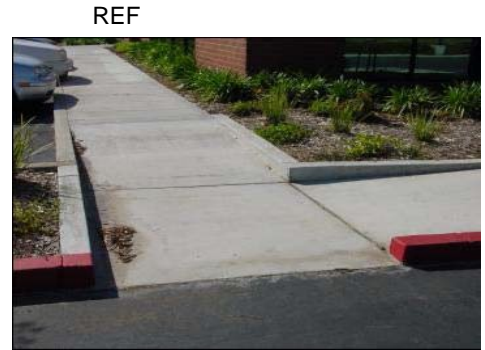
- *Original Problem Description:*
The concrete curb ramp does not provide a detectable warning surface which includes truncated domes.

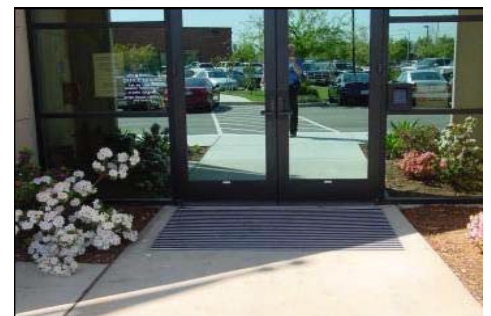
- *Original Problem Description:*
There is insufficient clear floor space provided at the electronic keypad to the right of the main entrance.

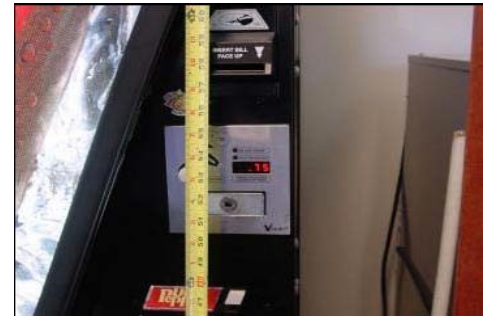
- *Original Problem Description:*
The side reach height of the controls on the vending machine in the break room is greater than 54 inches above the floor.

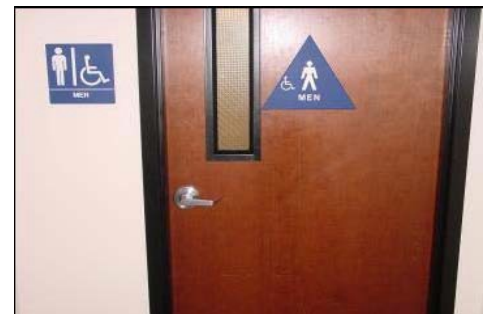
- *Original Problem Description:*
There is signage indicating accessibility on the entry door to the restroom. The signage is centered 60 inches above the floor on the latch side of the entrance door and includes Braille and raised lettering, gender use symbol and the ISA symbol.

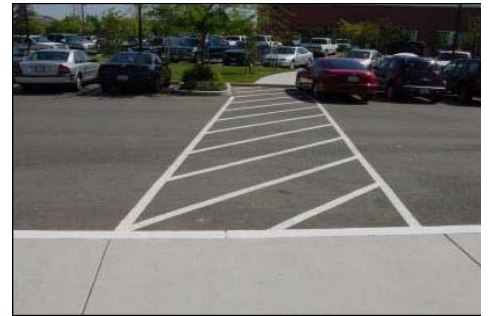
• *Original Problem Description:*
 There is no required striped access aisle adjacent to the passenger loading zone by the main entrance. There is no signage designating accessibility posted at the passenger loading zone.

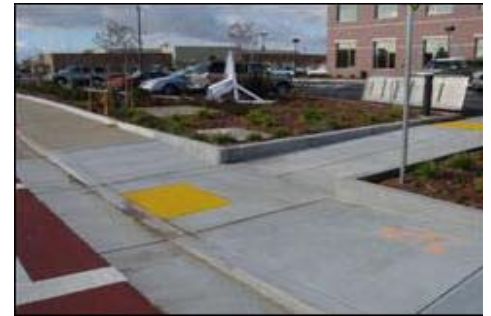
• *Original Problem Description:*
The curb ramp connecting the public right of way off Laguna Palm Way to the path of travel to the building is on city property, though provides access to programs, services, and activities.

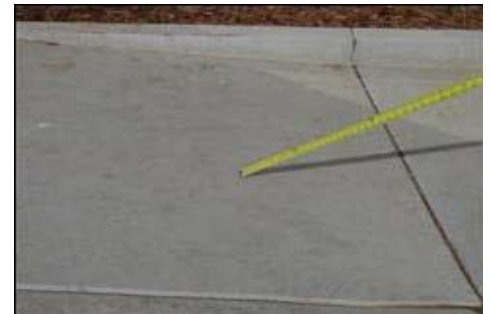
• *Original Problem Description:*
The curb ramps do not provide a detectable warning surface which includes truncated domes.

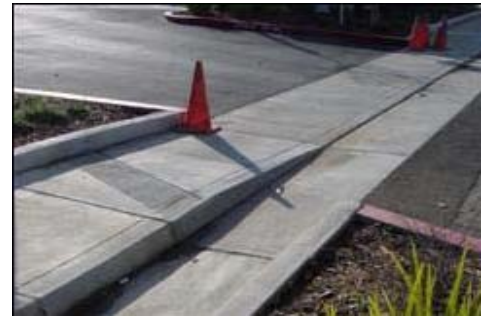
- *Original Problem Description:*
The curb ramps do not provide a detectable warning surface which includes truncated domes.

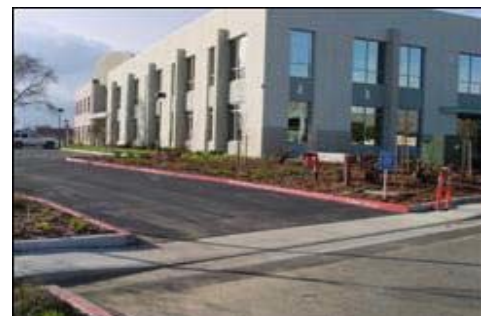
- *Original Problem Description:*
The concrete curb ramps do not provide a detectable warning surface which includes truncated domes.

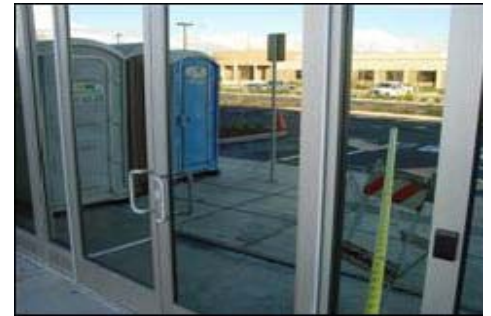
- *Original Problem Description:*
The main entrances do not have accessible signage mounted on the wall adjacent to the latch side of the doors.

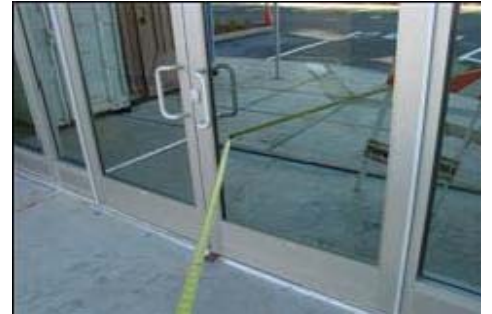
- *Original Problem Description:*
There is no signage with the International Symbol of Accessibility on the entrance doors to the facility designating them as accessible

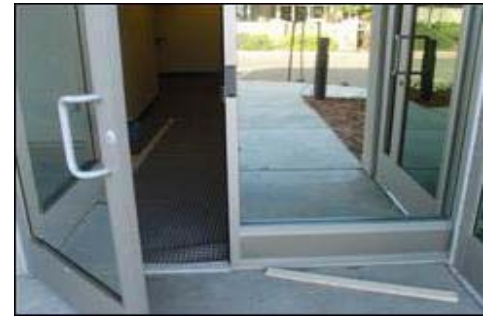
- *Original Problem Description:*
The employee entrance doors do not have accessible signage mounted on the wall adjacent to the latch side of the door.

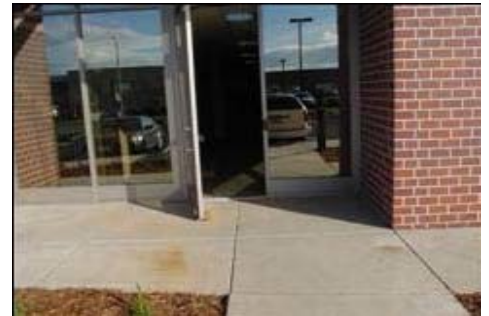
- *Original Problem Description:*
There is no signage with the International Symbol of Accessibility on the employee entrance doors to the facility designating them as accessible.

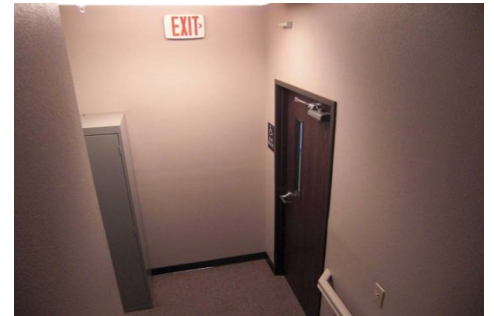
- *Original Problem Description:*
At exit discharge level, there is no sign including a raised five pointed star located to the left of the identifying floor level

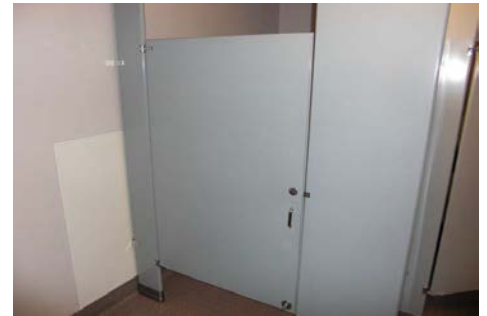
- *Original Problem Description:*
The stile is 8" and should be no more than 4" maximum on this end opening door accessible toilet compartment. Further, the 18" stall front on the right side is on the wrong side of the door based on the position of the toilet.
- *Original Solution:*
Reconfigure the front stall wall so that the door is located in front of the space on the wide side of the toilet and not in front of the toilet and the stile is no more than 4" maximum. CBC 1115B.3.1 4.3
