# **Dunisch Property Custom Report**

## DUNISCH PROPERTY, ELK GROVE, SACRAMENTO COUNTY, CALIFORNIA

### DUNISCH PROPERTY, ELK GROVE, SACRAMENTO COUNTY, CALIFORNIA (USFWS# RP-DUNISCH PROPERTY - 2023-0206)

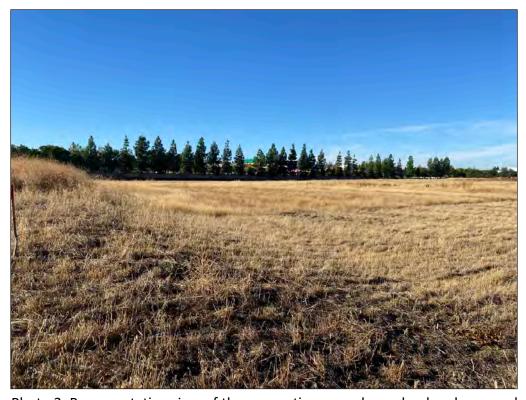
Photo 1. Representative view of the non-native annual grassland looking south. Photo taken on 9/28/2022.

Photo 2. Representative view of the non-native annual grassland and seasonal wetland looking southwest. Note that the seasonal wetland is located at the base of the slope. Photo taken on 9/28/2022.

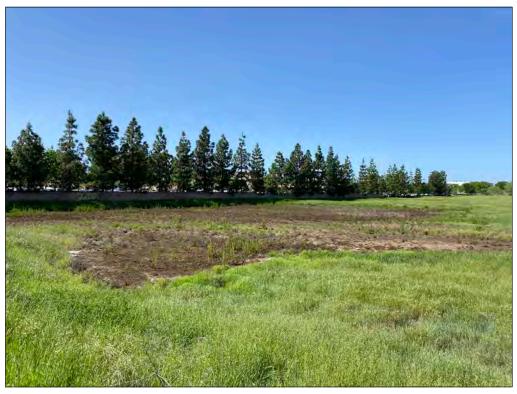
Photo 5. Representative view of the southern portion of SW-4 looking southwest towards Home Depot. Photo taken 4/24/2023.

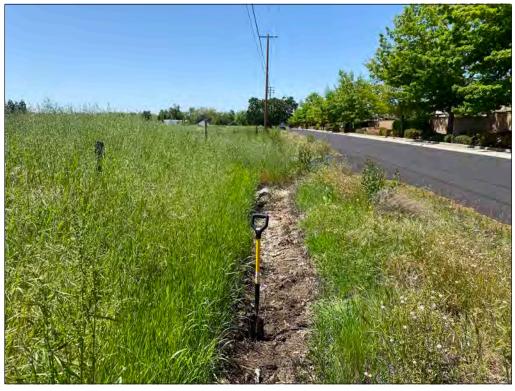
Photo 6. Representative view of the roadside ditch (D-1) looking west along Dunisch Road. Note that D-1 drains SW-4 within the Study Area. Photo taken 4/24/2023.

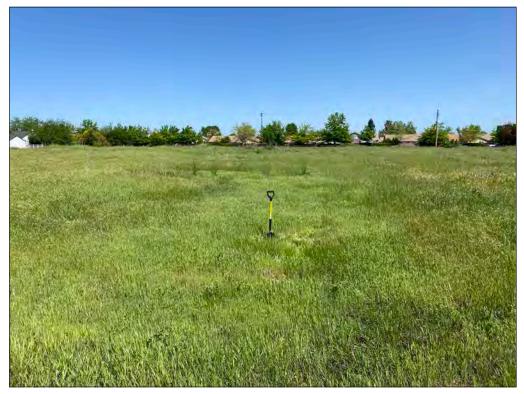
Photo 3. Representative view of the SW-2 looking north. Note that the shovel is in the central portion of the wetland. Photo taken 4/24/2023.

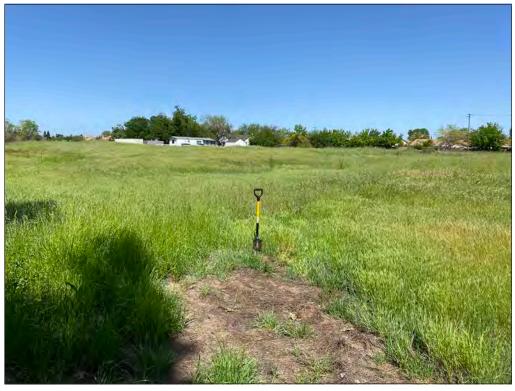
Photo 4. Representative view of the SW-3 looking northwest. Note that the shovel is near the edge of the wetland and SW-2 is visible slightly above the shovel handle. Photo taken 4/24/2023.

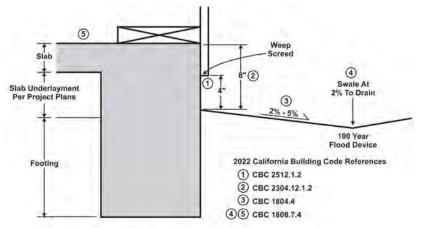
Typical 2022 California Building Code Drainage Requirements

All grades should provide rapid removal of surface water runoff; ponding water should not be allowed on building pads or adjacent to foundations or other structural improvements (during and following construction). All soils placed against foundations during finish grading should be compacted to minimize water infiltration. Finish and landscape grading should include positive drainage away from all foundations. Section 1808.7.4 of the 2022 California Building Code (CBC) states that for graded soil sites, the top of any exterior foundation shall extend above the elevation of the street gutter at the point of discharge or the inlet of an approved drainage device a minimum of 12 inches plus 2 percent. If overland flow is not achieved adjacent to buildings, the drainage device should be designed to accept flows from a 100-year event. Grades directly adjacent to foundations should be no closer than 8 inches from the top of the slab (CBC 2304.12.1.2), and weep screeds are to be placed a minimum of 4 inches clear of soil grades and 2 inches clear of concrete or other hard surfacing (CBC 2512.1.2). From this point, surface grades should slope a minimum of 2 percent away from all foundations for at least 5 feet but preferably 10 feet, and then 2 percent along a drainage swale to the outlet (CBC 1804.4). Downspouts should be tight piped via an area drain network and discharged to an appropriate non-erosive outlet away from all foundations.

The above referenced elements pertaining to drainage of the proposed structures is provided as general acknowledgement of the California Building Code requirements, restated and graphically illustrated for ease of understanding. Surface drainage design is the purview of the Project Architect/Civil Engineer. Review of drainage design and implementation adjacent to the building envelopes is recommended as performance of these improvements is crucial to the performance of the foundation and construction of rigid improvements.

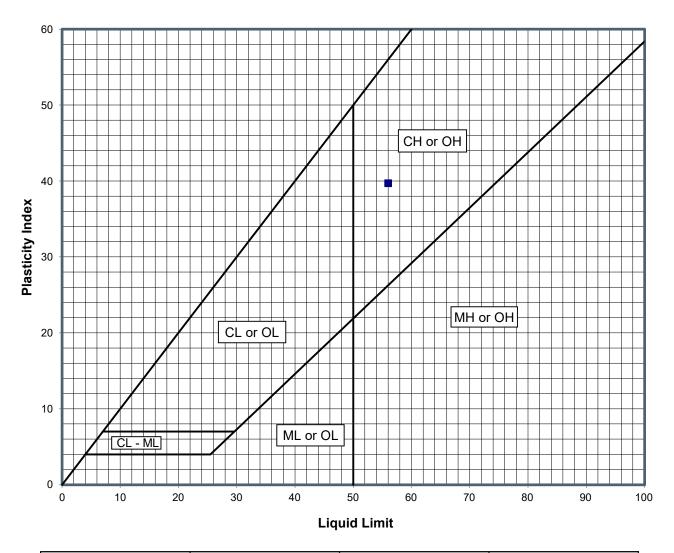
## Liquid Limit, Plastic Limit, and Plasticity Index of Soils, ASTM D4318, Method A

Liquid Limit	Plastic Limit	Plasticity Index	Unified Soil Classification, ASTM D2487
56	16	40	CH

Material Description: Olive Brown Fat CLAY with Sand

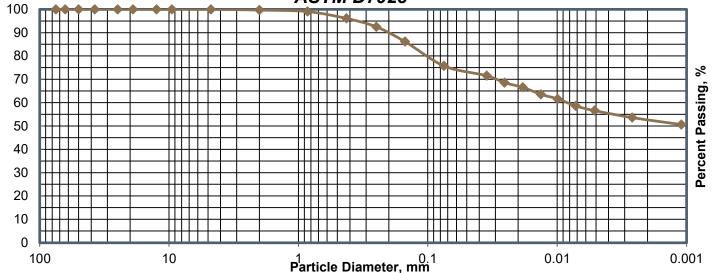
# Particle-Size Distribution of Fine-Grained Soils Using the Sedimentation Analysis, ASTM D7928

Faiticle
Sieve A	nalysis
US Standard Sieve Size	Percent Passing
3 Inch (75 mm)	100
2 1/2 Inch (63.5 mm)	100
2 Inch (50 mm)	100
1 1/2 Inch (37.5 mm)	100
1 Inch (25 mm)	100
3/4 Inch (19 mm)	100
1/2 Inch (12.5 mm)	100
3/8 Inch (9.5 mm)	100
No. 4 (4.75 mm)	100
No. 10 (2 mm)	100
No. 20 (850 μm)	99
No. 40 (425 μm)	96
No. 60 (250 μm)	93
No.100 (150 μm)	86
No. 200 (75 μm)	75.8

Hydrometer Analysis					
Particle Diameter,	Percent Passing				
mm	reideill Fassing				
0.035	71.6				
0.026	68.6				
0.018	66.6				
0.013	63.6				
0.010	61.6				
0.007	58.6				
0.005	56.6				
0.003	53.6				
0.001	50.6

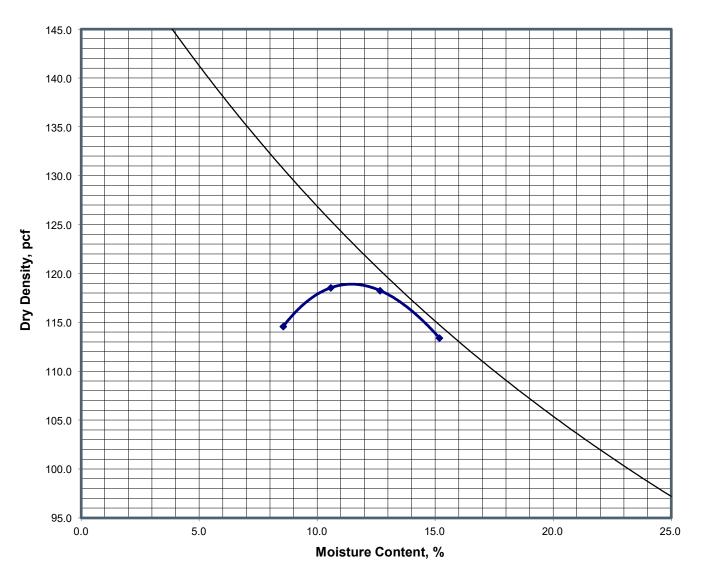
# Laboratory Compaction Characteristics of Soil Using Modified Effort (56,000 lf-lbf/ft3), ASTM D1557, Method A

Zero Air Voids Curve at 100% Saturation;
 Specific Gravity Estimated at: 2.55

Maximum Dry Density, pcf: 118.9 Optimum Moisture Content, %: 11.5

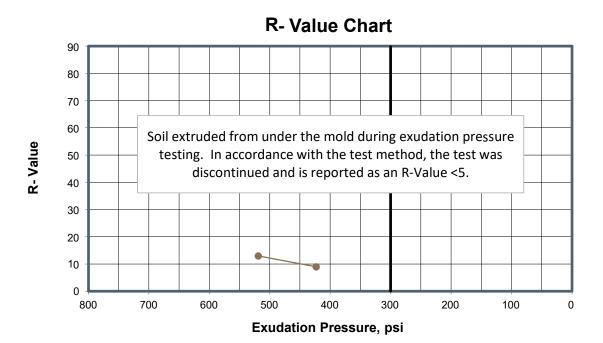
### Resistance "R" Value of Soil and Soil-Aggregate Mixtures, CTM 301

Test Specimen No.:	1	2	3
Moisture Content at Test, %	9.9	11.9	14.4
Dry Density at Test, pcf	118.0	113.4	107.0
Expansion Pressure, psf	113	22	
Exudation Pressure, psi	519	423	
Resistance "R" Value			
"R" Value at 300 psi Exudation	<5

Material Description: Brown CLAY

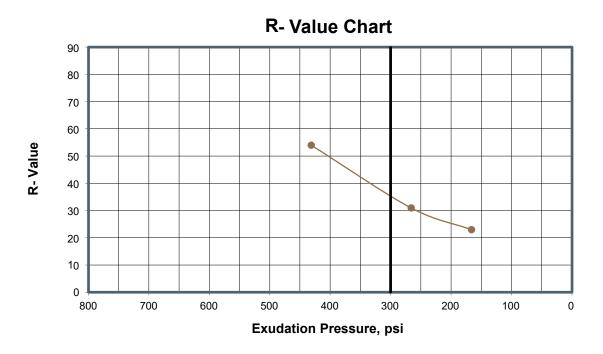
### Resistance "R" Value of Soil and Soil-Aggregate Mixtures, CTM 301

Test Specimen No.:	1	2	3
Moisture Content at Test, %	14.1	15.2	15.7
Dry Density at Test, pcf	119.6	116.1	115.2
Expansion Pressure, psf	255	56	61
Exudation Pressure, psi	431	266	166
Resistance "R" Value	54	31	23
"R" Value at 300 psi Exudation	35

Material Description: Olive Brown Sandy Clay

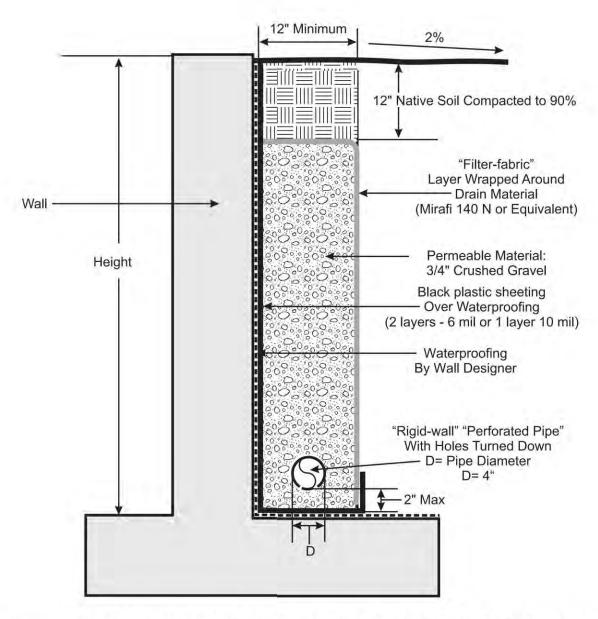
(Typical Cross Section)

- 1. Slope footing and "rigid-wall" pipes along flow line parallel to wall at least 1% gradient to drain to an appropriate outfall area away from residence.
- 2. Use "sweeps" for directional changes in pipe flow (do not use 90°elbows).
- 3. Provide periodic "clean-outs".
- 4. Washed clean permeable material.

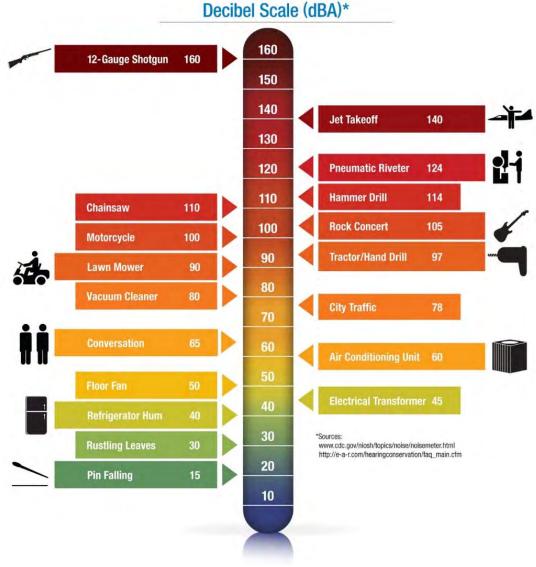
Figure 2
Typical A-Weighted Sound Levels of Common Noise Sources

Community noise is commonly described in terms of the "ambient" noise level, which is defined as the all-encompassing noise level associated with a given noise environment. A common statistical tool to measure the ambient noise level is the average, or equivalent, sound level ( $L_{eq}$ ) over a given time period (usually one hour). The  $L_{eq}$  is the foundation of the Day-Night Average Level noise descriptor,  $L_{dn}$  or DNL, and shows very good correlation with community response to noise.
