# **APPENDIX A**

## **AIR QUALITY AND GHG MODELING RESULTS**

**Waterman Brinkman Project**  
**Sacramento Metropolitan AQMD Air District, Annual**

This report summarizes the findings of a Biological Resources Assessment (BRA) completed by HELIX Environmental Planning, Inc. (HELIX) for the 20.6-acre Waterman Brinkman Logistics Center Project located within the City of Elk Grove, Sacramento County, California. This document addresses the site’s physical features, plant communities present, and plant and wildlife species occurring or potentially occurring in the Study Area. Furthermore, the suitability of habitats to support special-status species and sensitive habitats are analyzed, and recommendations are provided for any regulatory permitting or further analysis required prior to development activities occurring on the site.

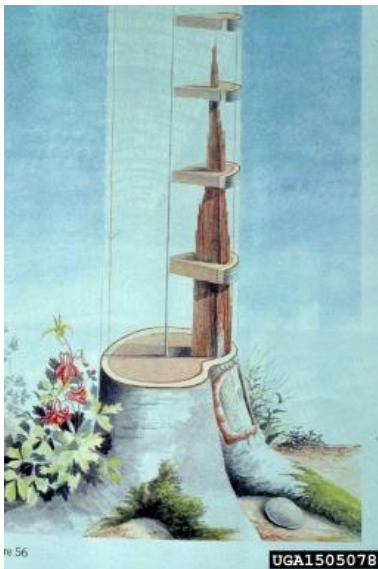
**Decay (in General):** Fungi cause all decay of living trees. Decay is considered a disease because cell walls are altered, wood strength is affected, and living sapwood cells may be killed. Fungi decay wood by secreting enzymes. Different types of fungi cause different types of decay through the secretion of different chemical enzymes. Some decays, such as white rot, cause less wood strength loss than others because they first attack the lignin (causes cell walls to thicken and reduces susceptibility to decay and pest damage) secondarily the cellulose (another structural component in a cell walls). Others, such as soft rot, attack the cellulose chain and cause substantial losses in wood strength even in the initial stages of decay. Brown rot causes wood to become brittle and fractures easily with tension. Identification of internal decay in a tree is difficult because visible evidence may not be present.

According to Evaluation of Hazard Trees in Urban Areas (Matheny, 1994) decay is a critical factor in the stability of the tree. As decay progresses in the trunk, the stem becomes a hollow tube or cylinder rather than a solid rod. This change is not readily apparent to the casual observer. Trees require only a small amount of bark and wood to transport water, minerals and sugars. Interior heartwood can be eliminated (or degraded) to a great degree without compromising the transport process. Therefore, trees can contain significant amounts of decay without showing decline symptoms in the crown.

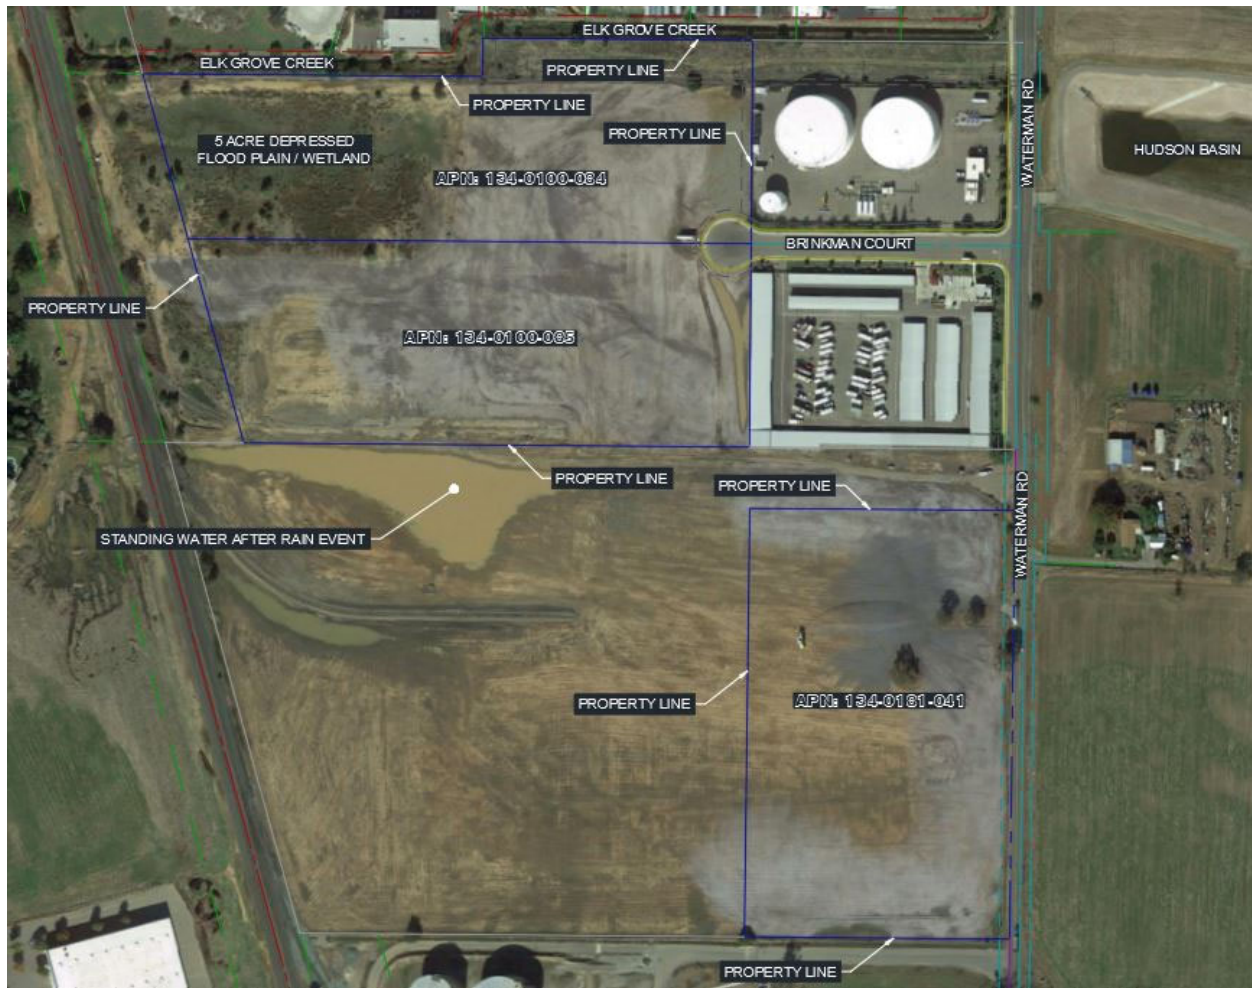
A topographic survey of the proposed projects is included in Appendix A. These topographic surveys include aerial photogrammetric surveys, which were used to supplement the existing HEC-RAS model, see the second portion of this report titled "Waterman & Brinkman Elk Grove Creek Preliminary Drainage Study" for more detail. The site itself general falls from southeast to northwest, and the slope varies from 0% to 2%. There is additionally a 5-acre depressed area at the northwest corner of the site. This area is currently considered in the floodplain and a wetland area. The area typically holds water throughout the wet season due to relatively flat slopes and a lack of outfall. Below is a satellite photo from 2016 showing the standing water during a rain event as well as the grading operation that occurred. The standing water can be seen in the large brown areas. The wetland can be seen undisturbed by the grading operation in the top left corner.

Figure 3 – Existing Conditions Standing Water

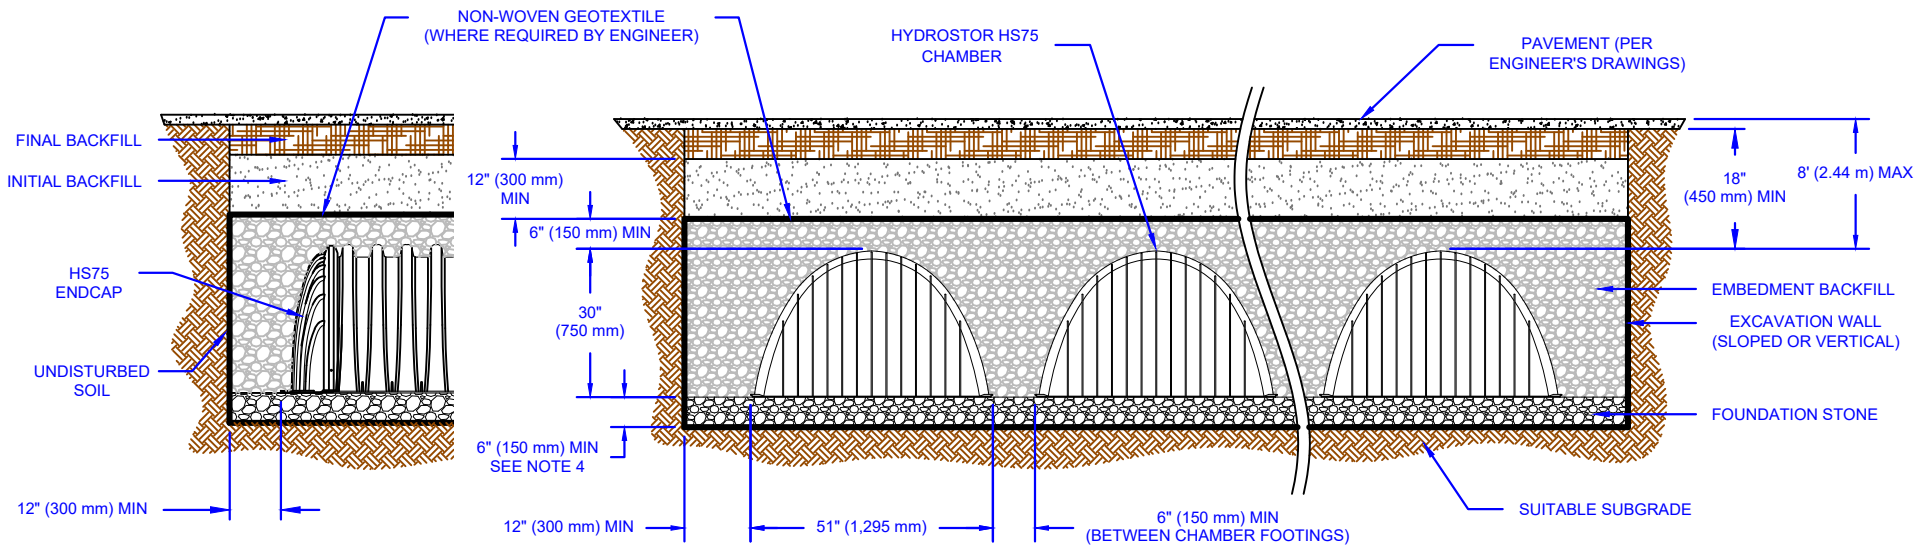
TITLE: HYDROSTOR HS75 - CROSS SECTION		
DRAWN BY: TJW	DATE: 22-Apr-20	DRAWING NUMBER: D-7-300A
SCALE: NTS	SHEET: 1 OF 1

- HYDROSTOR HS75 CHAMBERS** SHALL BE DESIGNED IN ACCORDANCE WITH ASTM F2787 AND SHALL CONFORM TO THE REQUIREMENTS OF ASTM F2418. HS75 CHAMBERS SHALL BE INSTALLED IN ACCORDANCE WITH THE MANUFACTURER'S LATEST INSTALLATION GUIDELINES.

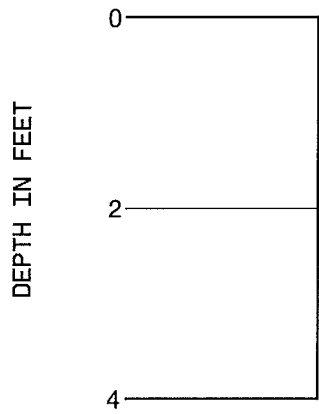
ML	TAN TO LIGHT BROWN FINE SANDY SILT - HARD, DRY, VARIABLY CEMENTED
SM ML	LIGHT BROWN SANDY SILT/SILTY SAND - DENSE, SL. MOIST, VARIABLY CEMENTED
SM	BROWN TO RUST-BROWN SILTY FINE SAND - DENSE, MOIST, VARIABLY CEMENTED

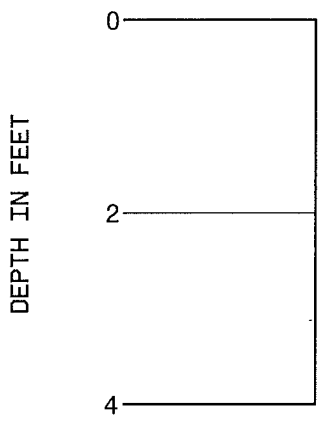
ML	DARK BROWN FINE SANDY CLAYEY SILT - STIFF, MOIST
CL CH	DARK GRAY TO BLACK SILTY CLAY WITH OCCASIONAL CHARCOAL SEAMS - STIFF, MOIST
SM	ORANGE-BROWN SILTY FINE SAND - DENSE, MOIST, CEMENTED

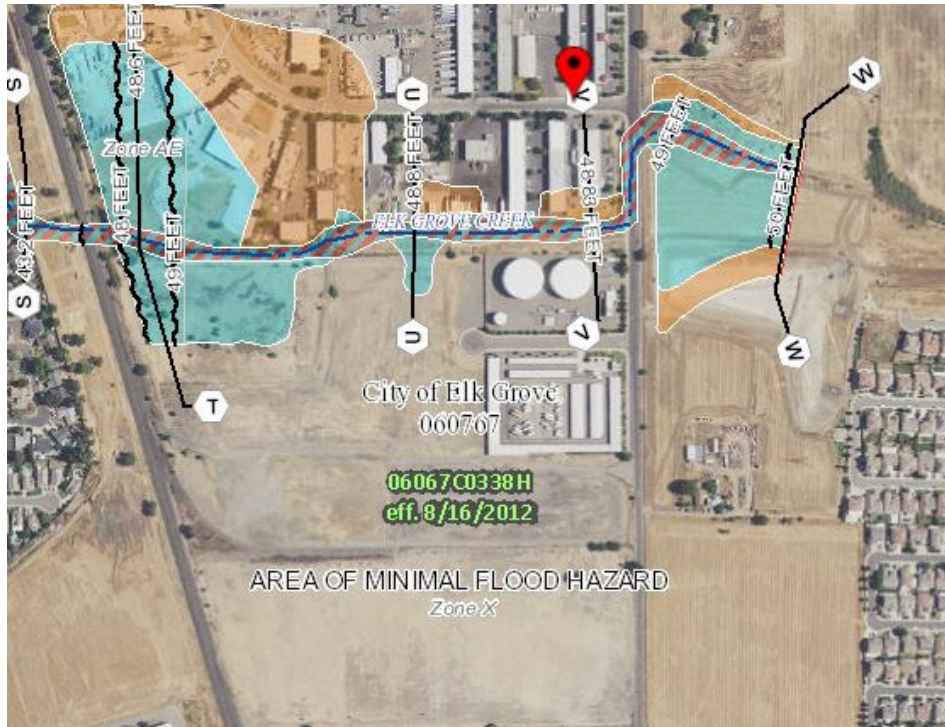
Figure 2 - FEMA Flood Map of Site

According to FEMA documents for the area, the site falls within FIRM Panel 06067C0338H. Making up a portion of FEMA cross-sections T and U. Approximately 5 acres of the site falls within the previously determined Special Flood Hazard Area along Elk Grove Creek. Specifically, portions of the Parcel fall within the Floodway and Zone AE. Copies of FIRM Panel 06067C0338H and relevant portions of FIS 06067C are included in Appendix B. The floodplain onsite is shown below.

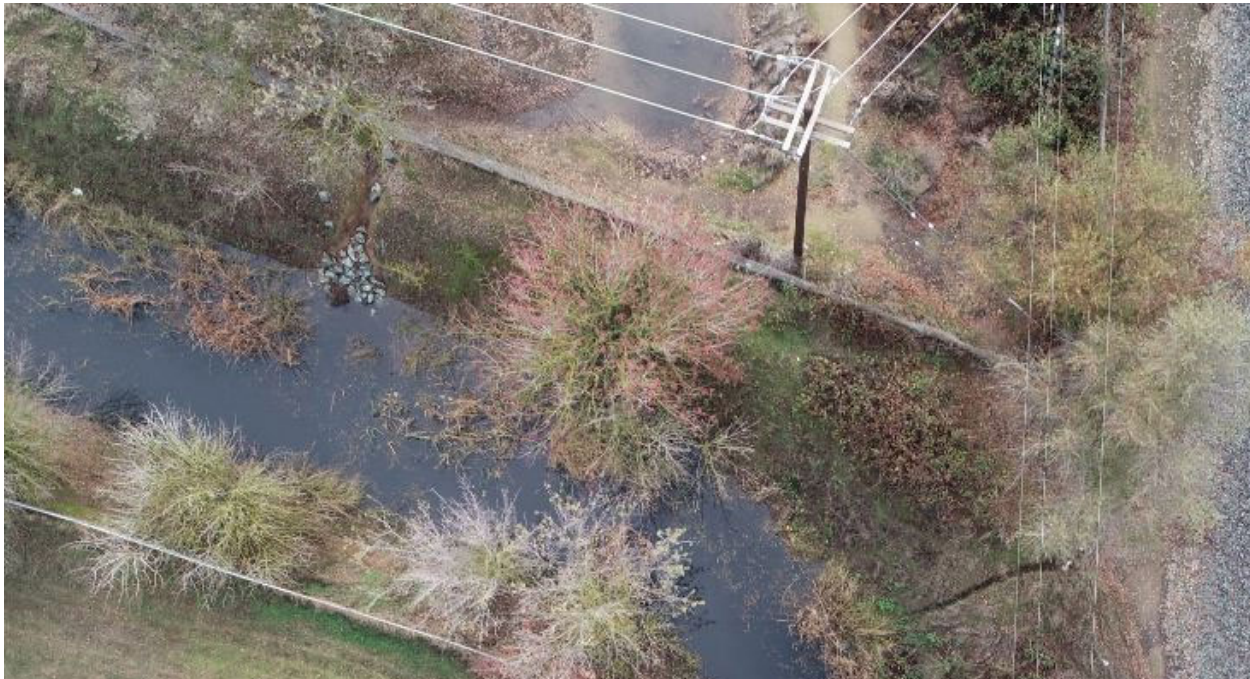
*Figure 4 – Existing Berm located on Elk Grove Creek*

In surveying the site, MCR located an existing berm located between the creek and the onsite floodplain. This berm was not discovered in both the master plan topography and the 2011 topographic survey. This berm has an elevation of approximately 44.5'-46'; near or above the flood elevation of 45'. During a 100-year event the berm would likely prevent water from entering the onsite flood plain, resulting in increased river stages upstream. As a conservative measure this finding was not used when creating the pre-project conditions; however, the berm was modeled for the applicable post-project river sections.

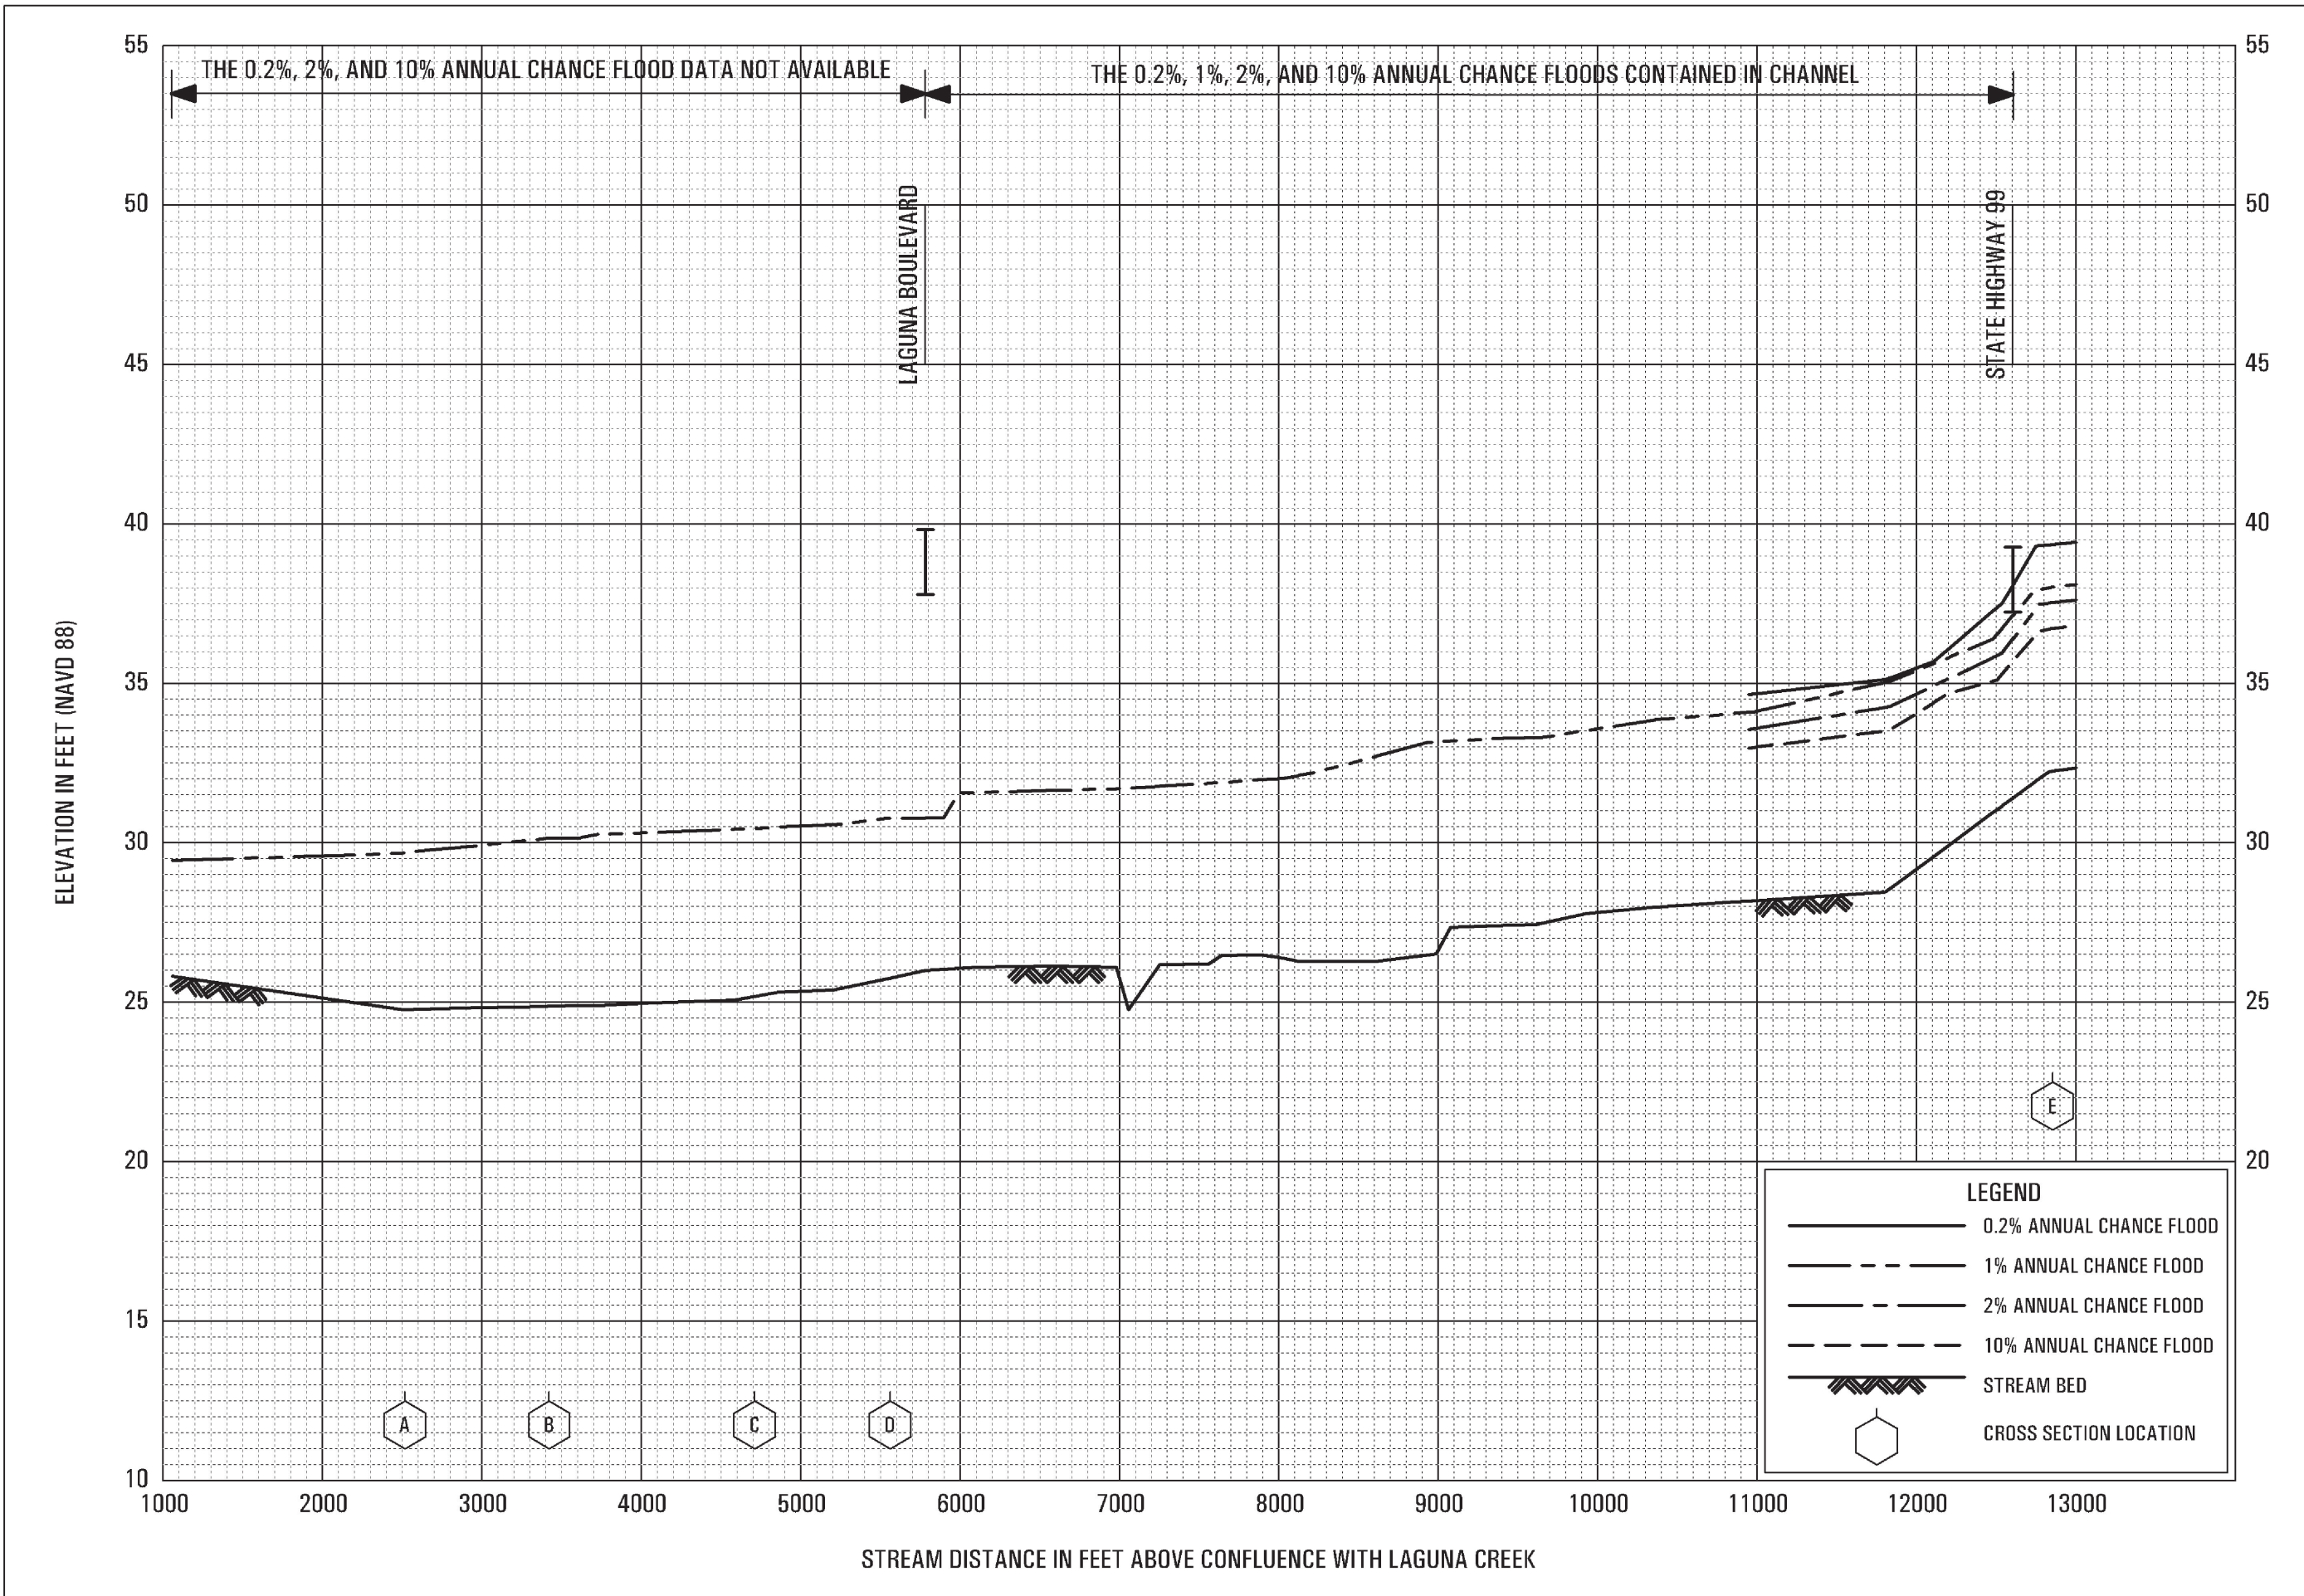
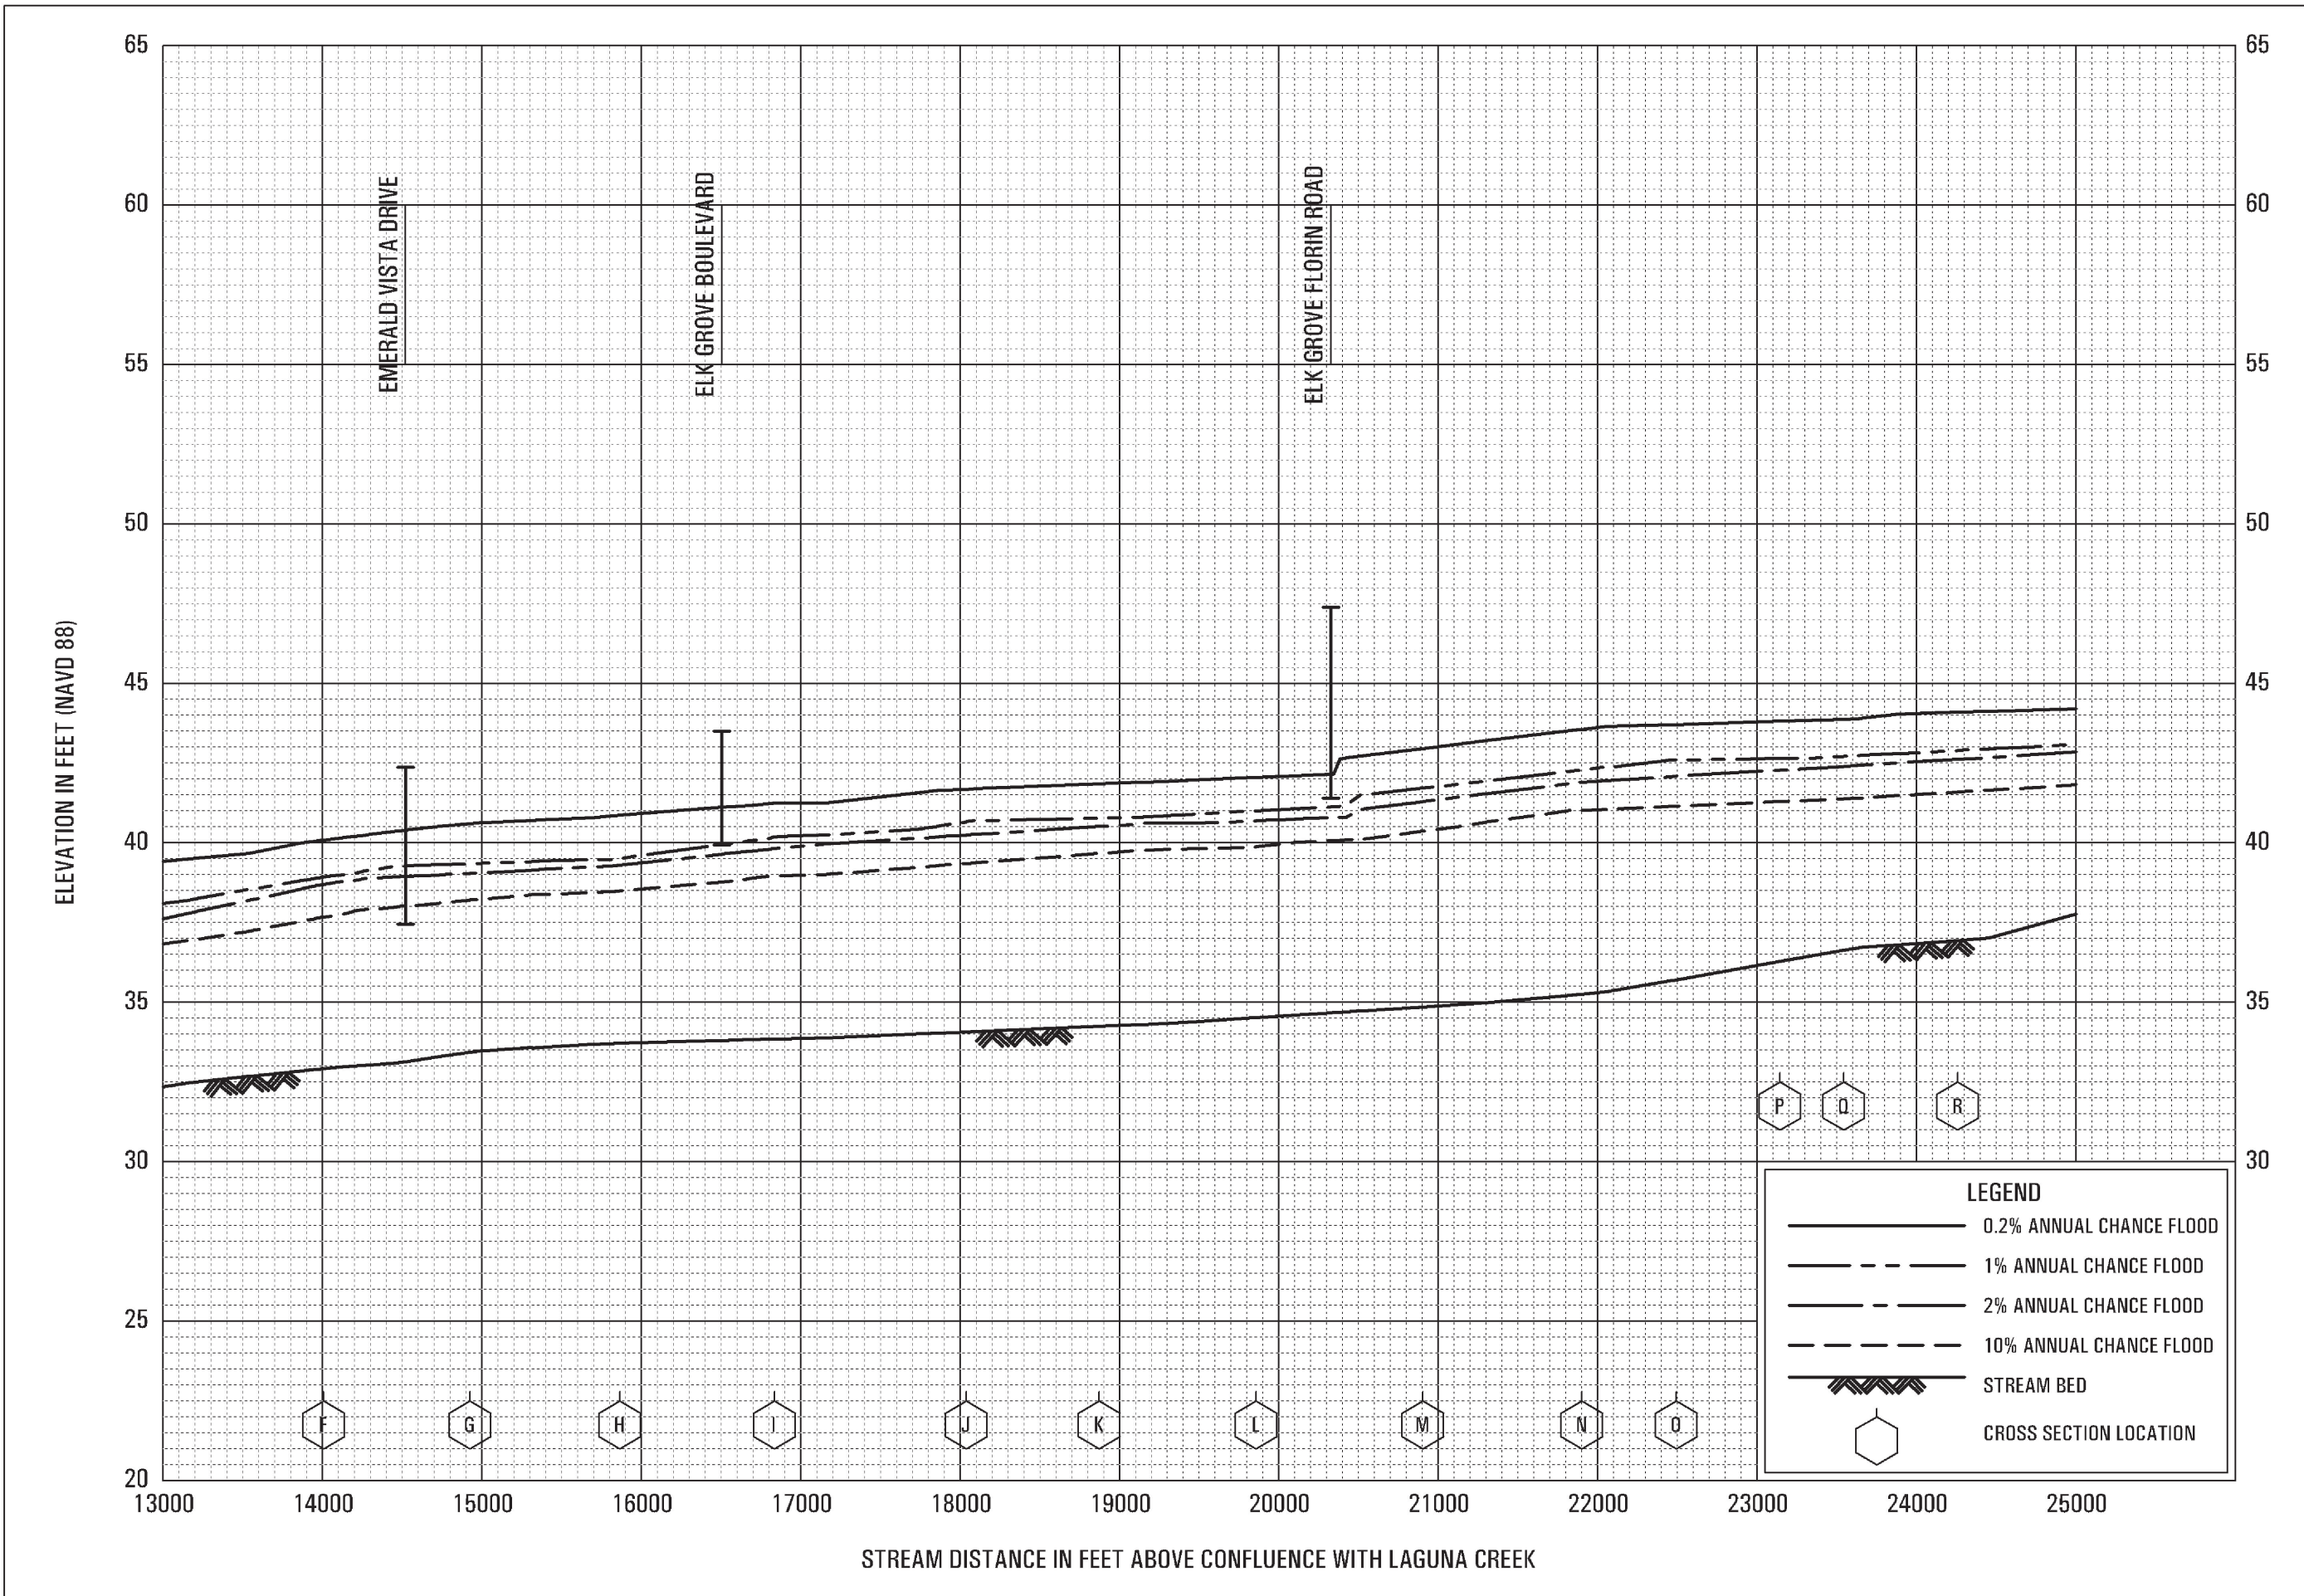
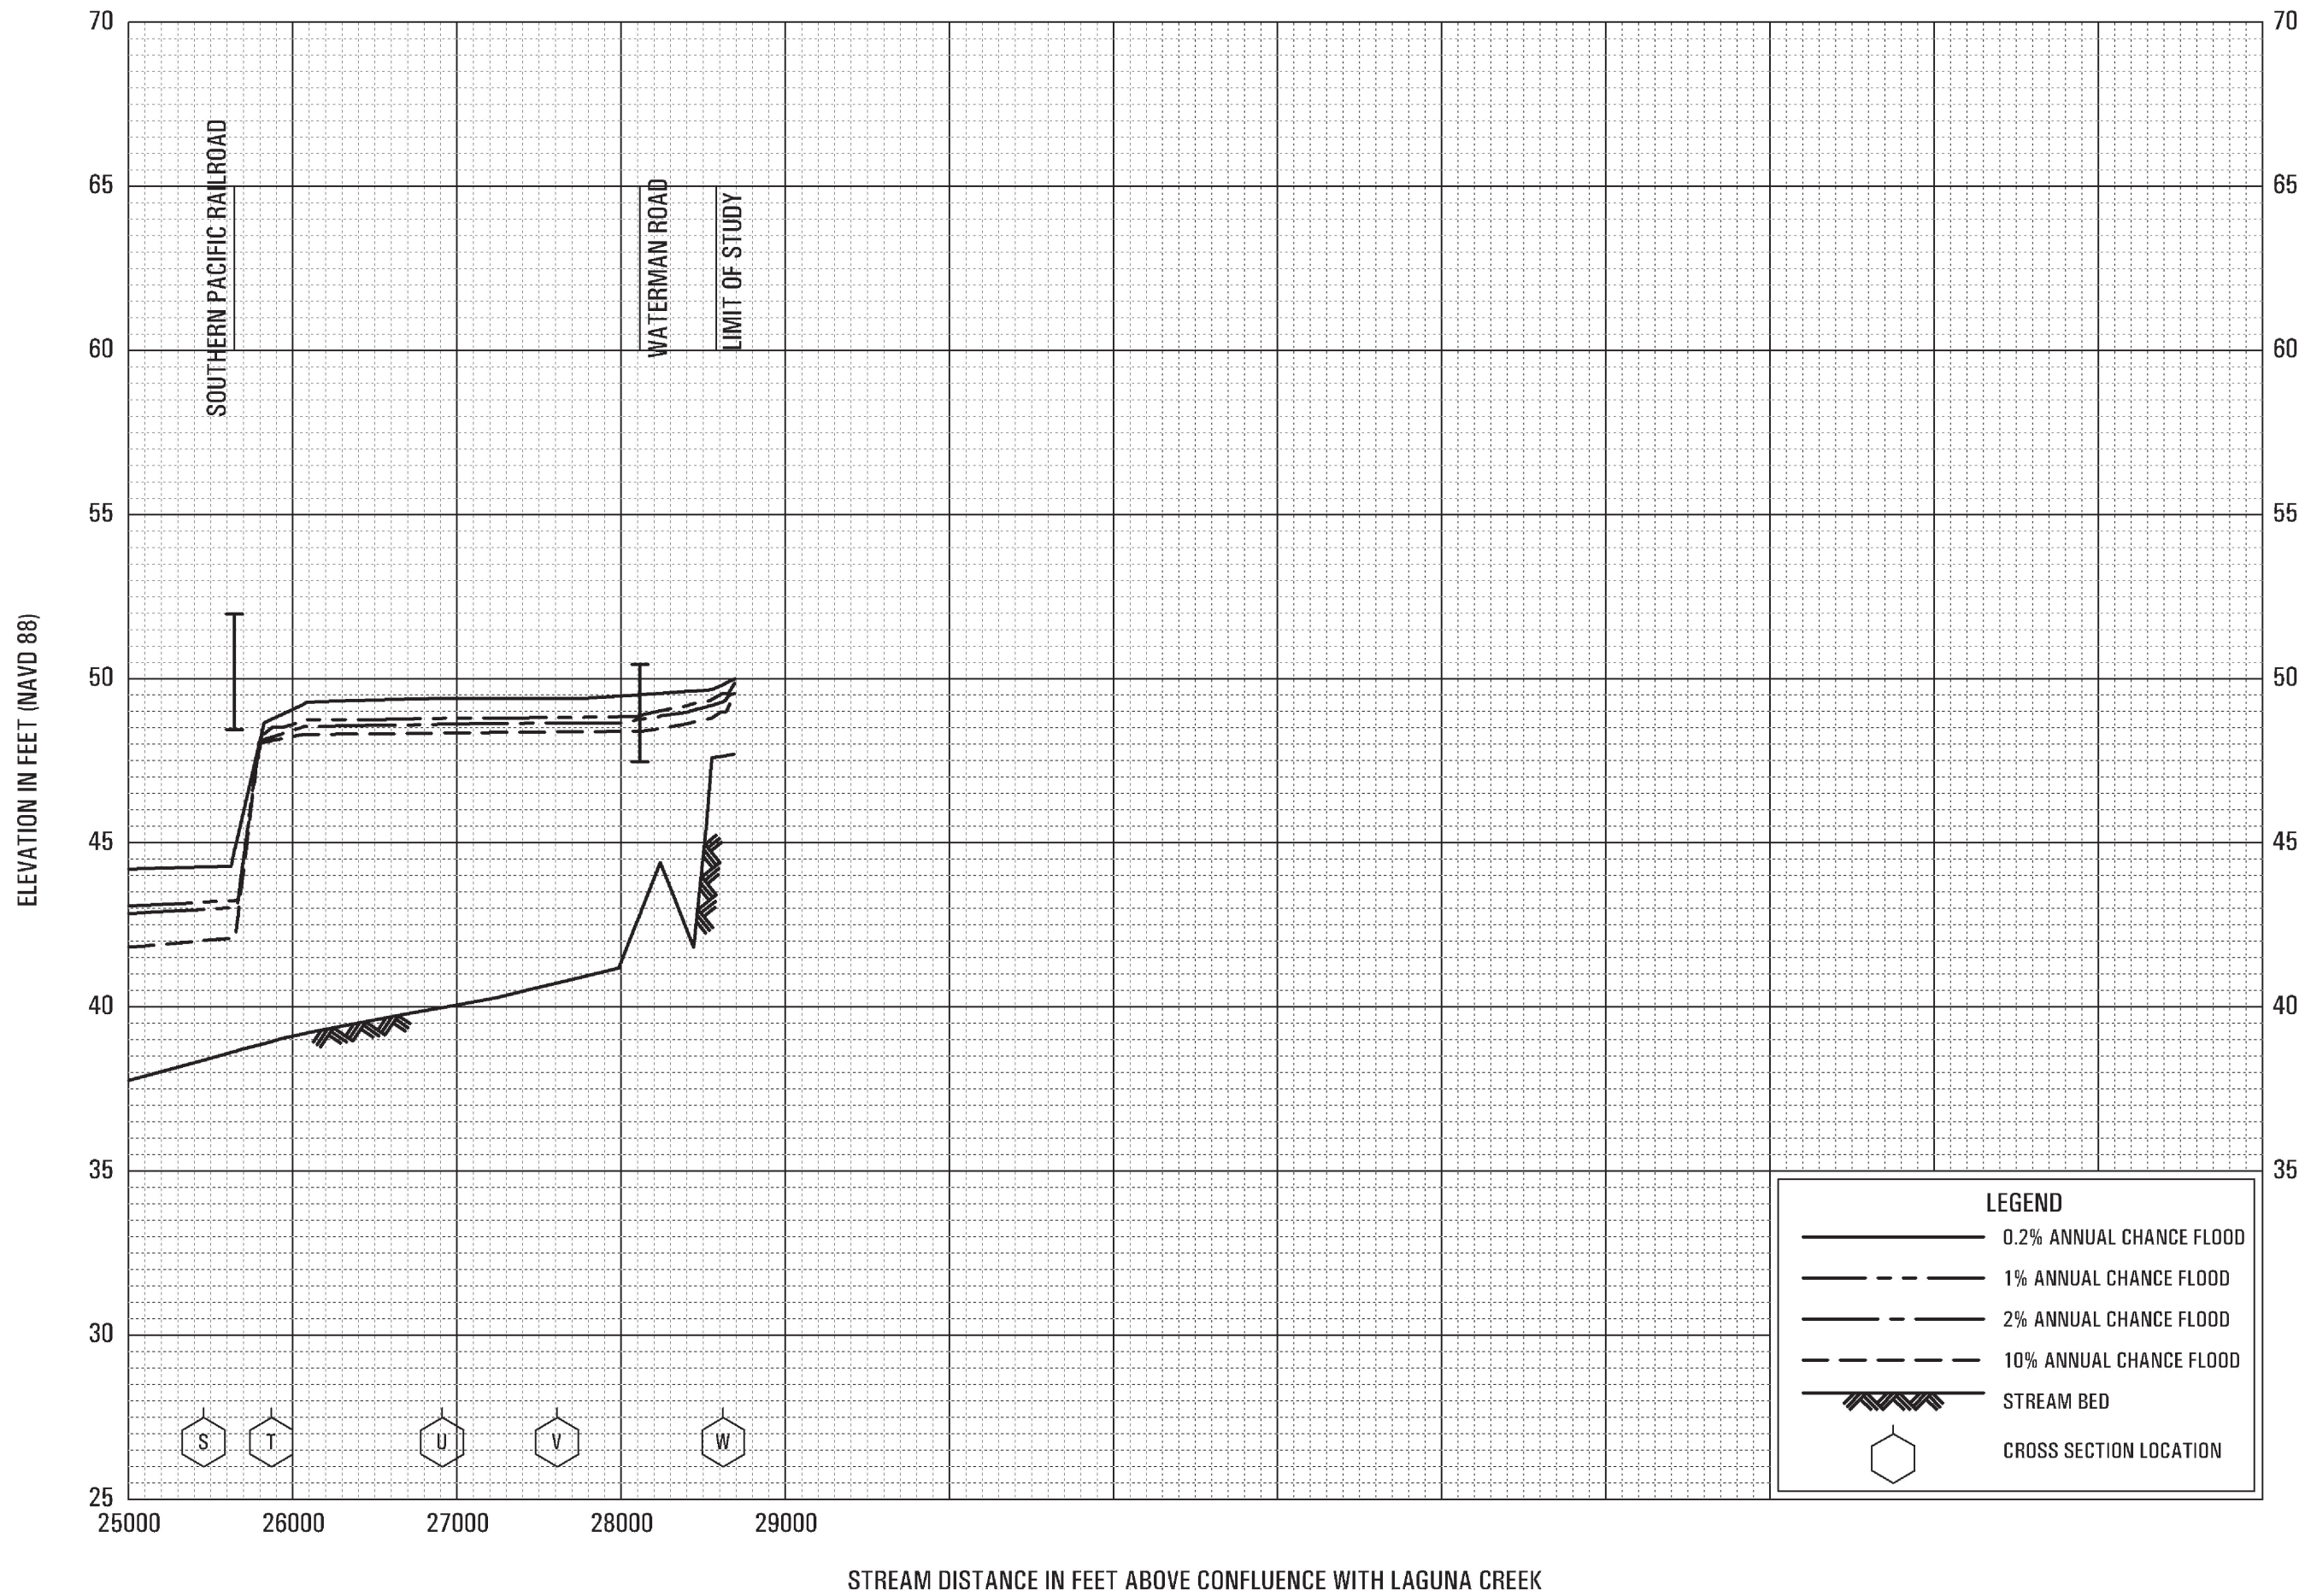
**FLOOD PROFILES**

**FLOODING SOURCE: ELK GROVE CREEK**
