#### **Visual Impact Assessment Memorandum**

#### Laguna Creek Inter-Regional Trail Crossing at State Route 99 Project

District 3 – SAC-99-14.3/14.4 EFIS Number: 0322000179

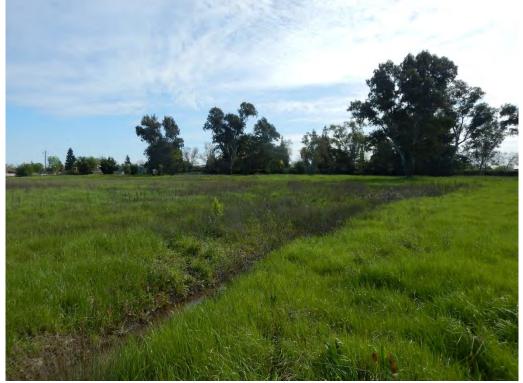
Representative Photograph 10. View of Seasonal Wetland (SW-8) (Waters of the U.S.). View is facing southeast.

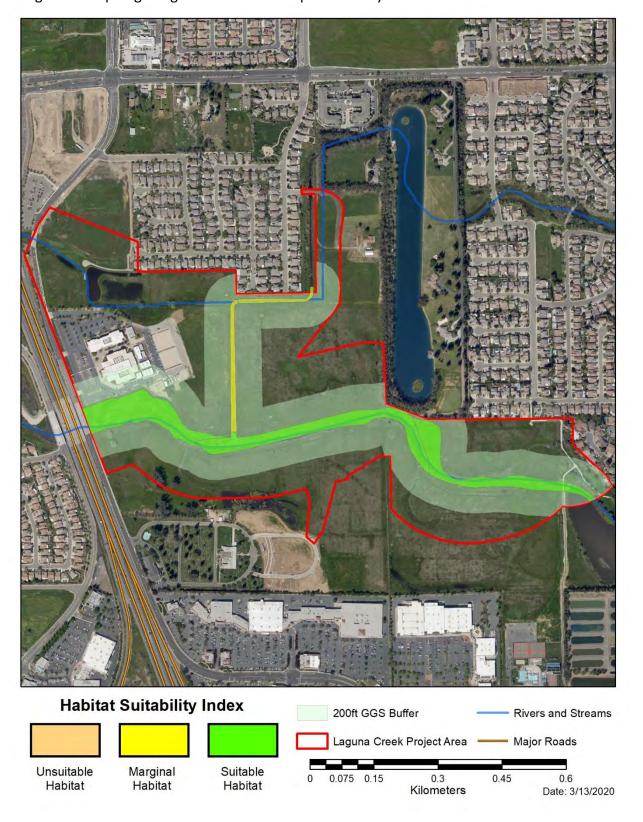
Figure 1. Map of giant gartersnake landscape suitability values
