CITY OF ELK GROVE

Facilities

Access Compliance Assessment Report

June 2018

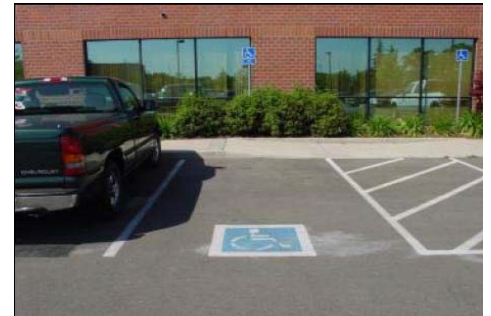
9207 Parking Lot at the Facility

Parking

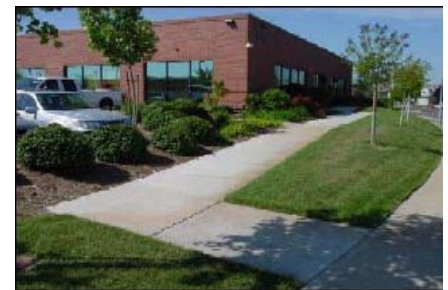
Directional Signage

- *Original Problem Description:*
There is no directional signage to the accessible entrance from the public right of way or other common use areas.

- *Mitigation Status:*
Non-Compliant
- *Date of Repair:*
N/A

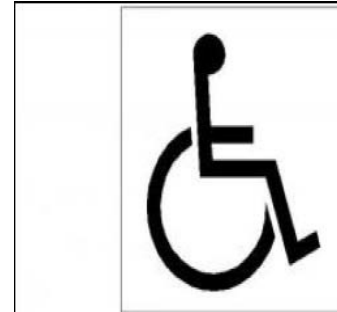
- *Original Problem Description:*
There is no signage with the International Symbol of Accessibility on the entrance door to the facility designating it as accessible.

• *Mitigation Status:*
Non-Compliant
• *Date of Repair:*
N/A

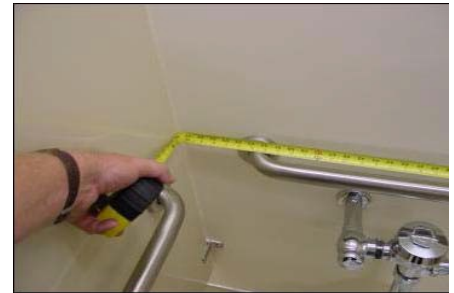
Men's Restroom in the Locker Room

- **Original Problem Description:**
There is insufficient clear floor space in the stall designated to be accessible in the restroom.

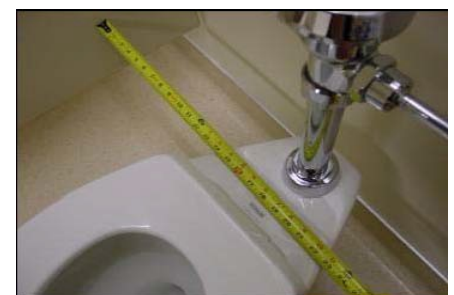
Men's Restroom in the Locker Room

- **Original Problem Description:**
The distance from the center of the toilet to the nearest side wall in the stall designated to be accessible in the restroom is greater than 18 inches.

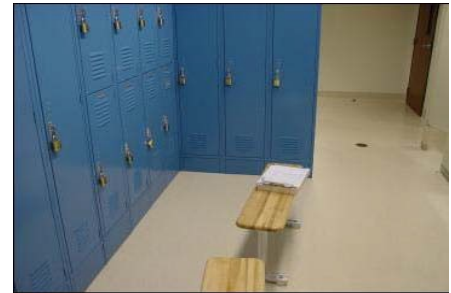
Men's Locker Room

- *Original Problem Description:*
Lockers are available for use in the men's locker room.

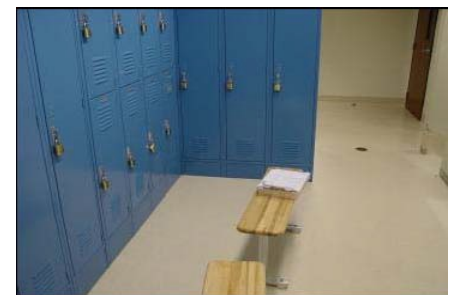
Men's Locker Room

- *Original Problem Description:*
The width of the benches in the locker room are less than 24 inches. The benches in the locker room is not fixed to the wall along the longer dimension.

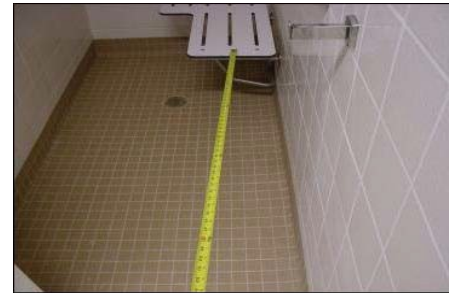
Men's Locker Room

• *Original Problem Description:*
 There is a folding seat in the shower compartment designated to be accessible in the men's locker room, however the seat does not extend the full length along the wall of the longer dimension.

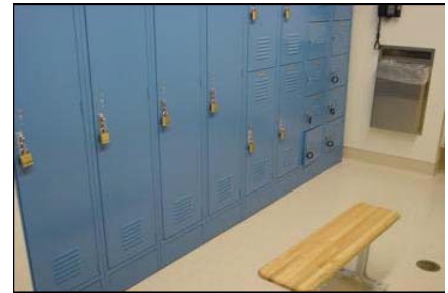
Women's Locker Room

- *Original Problem Description:*
Lockers are available for use in the women's locker room.

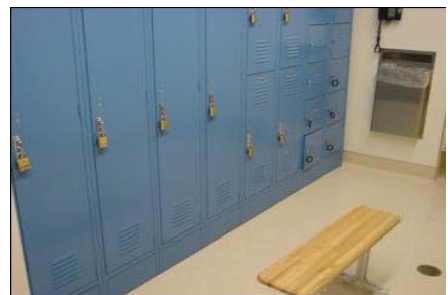
Women's Locker Room

- *Original Problem Description:*
The width of the bench in the locker room is less than 24 inches. The bench in the locker room is not fixed to the wall along the longer dimension.

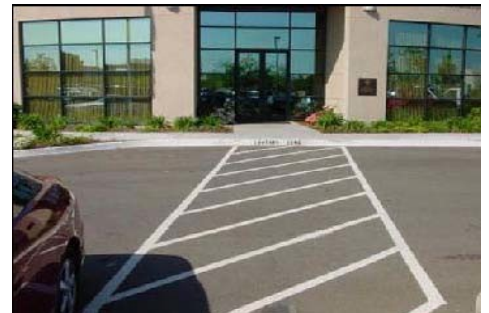
• *Original Problem Description:*
 There is no curb ramp provided at the passenger loading zone by the main entrance.

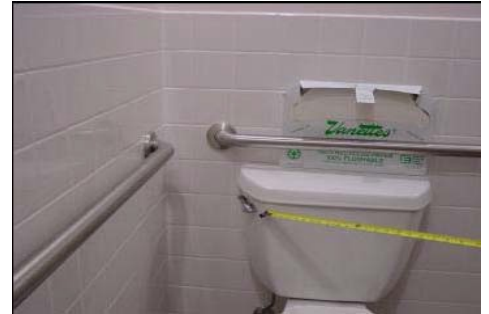
9245 Employee Only Women's Restroom in the Administration

Lavatory

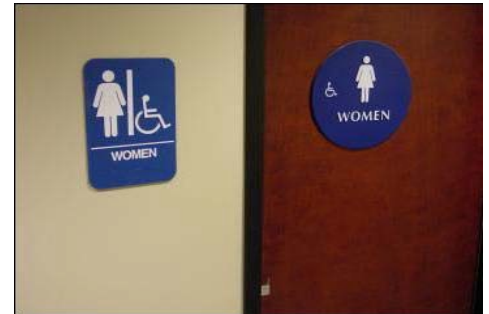
9249 Women's Restroom in the Main Lobby

Lavatory

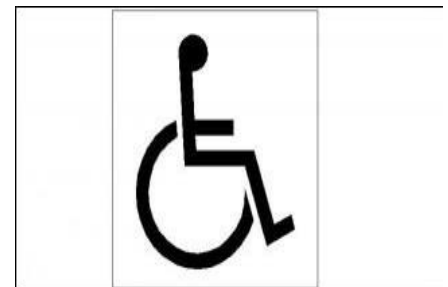
Accessible Assistance Signage

- *SSA As-Built Description:*
Signage to provide information regarding attendant services is missing.
- *SSA Proposed Solution:*
Provide sign stating "Attendant Service is Available"

• *Original Problem Description:*
The facility does not provide accessible signage at the reception counter that indicates there is assistance provided upon request.

• *Mitigation Status:*
Non-Compliant
• *Date of Repair:*
N/A

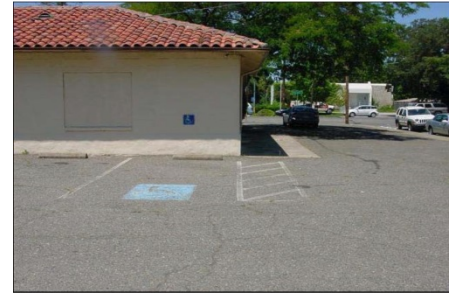
Accessible Parking

• *SSA As-Built Description:*
 Accessible parking spaces provided not accessible; multiple compliance violations.

• *Original Problem Description:*
 There is one accessible parking space out of six parking spaces marked, which is sufficient for compliance. The accessible parking space does not measure 108 inches wide and 216 inches long. The access aisle, located on the passenger's side (right side) of the parking space, measures less than the required 96 inches wide. The parking space is not "vanaccessible". The access aisle does not contain "NO PARKING" in

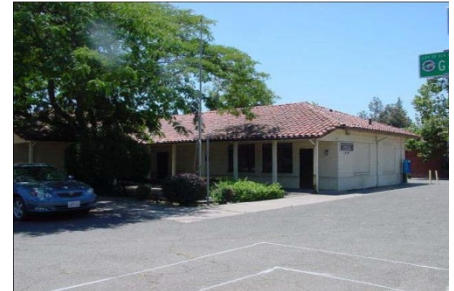
Accessible Route from the Public Right of Way

• *Original Problem Description:*
The surface of the path of travel is rough and uneven, providing a hazardous surface for individuals with mobility impairments and the general public. There are slopes greater than 5% on the path of travel from the sidewalk off of Elk Grove Boulevard to the facility.

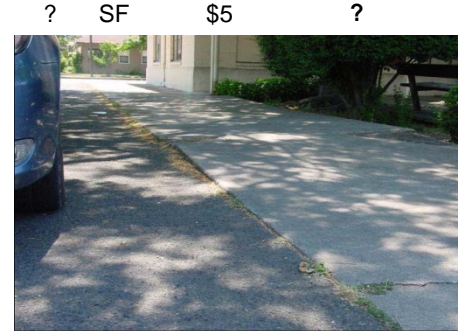
Sidewalk in front of the Main Entrance

• *Original Problem Description:*
The surface of the primary sidewalk path of travel to the main entrance and the courtyard is rough and uneven, providing a hazardous surface for individuals with mobility impairments and the general public.

Priority **1**
Severity **3**

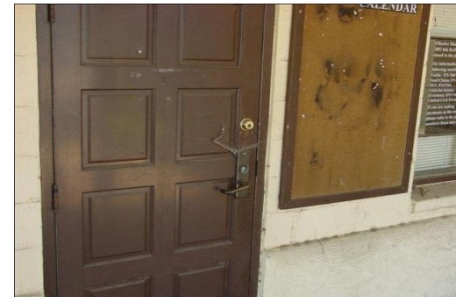
Main Entrance Door

- *Original Problem Description:*
There is no signage with the International Symbol of Accessibility on the entrance door to the facility designating it as accessible.

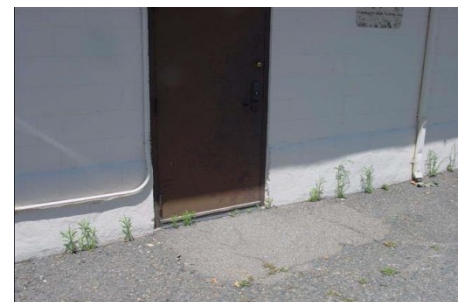
Rear Entrance Door

- *Original Problem Description:*
There is no level landing provided at the rear entrance door.

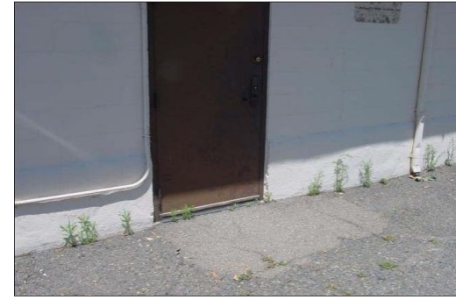
Rear Entrance Door

- *Original Problem Description:*
The height of the threshold at the entrance door is greater than 1/4 inch but does not exceed 1/2 inch.

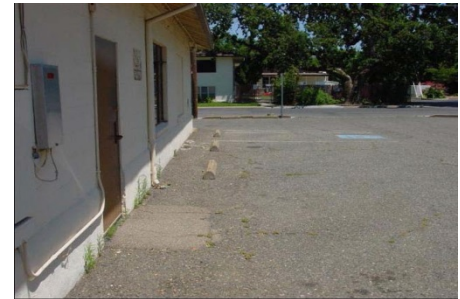
Rear Entrance Door

- *Original Problem Description:*
The rear entrance door does not have accessible signage mounted on the wall adjacent to the latch side of the door.

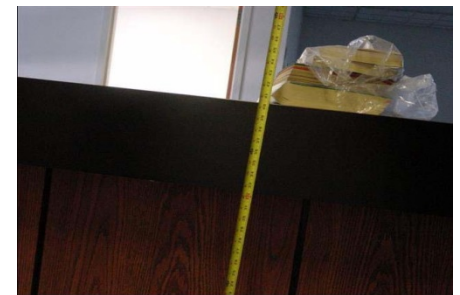
Reception Counter

• *Mitigation Status:*
No Action
• *Date of Repair:*
N/A

• *Notes:*
This counter has been eliminated with the remodel and a compliant element has been used in its place

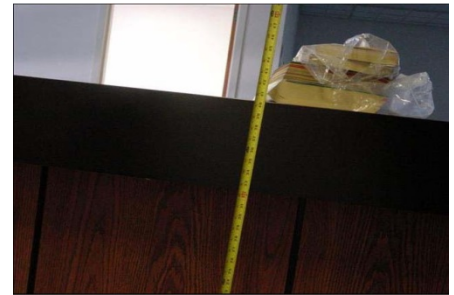
Reception Counter

- *SSA As-Built Description:*
Signage to provide information regarding attendant services is missing.
- *SSA Proposed Solution:*
Provide sign stating "Attendant Service is Available".

- *Original Problem Description:*
The facility does not provide accessible signage at the reception counter that indicates there is assistance provided upon request.

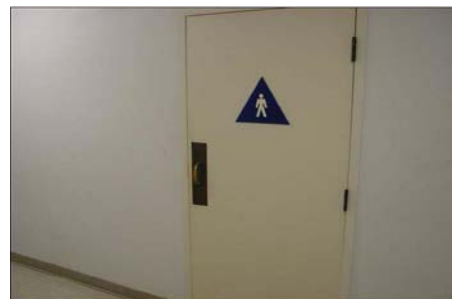
Men's Restroom

- *Original Problem Description:*
There is no signage indicating accessibility on the latch side of the entry door of the restroom.

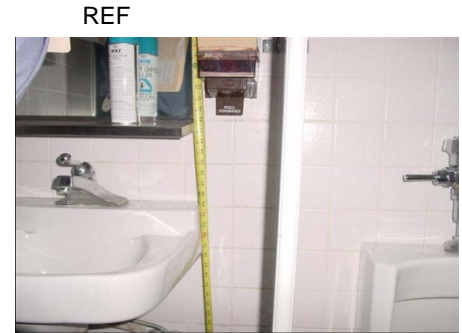
Men's Restroom

- *SSA As-Built Description:*
Bottom of mirror located above lavatories or countertops more than 40" above floor.
- *SSA Proposed Solution:*
Relocate or provide new accessible mirror.

- *Original Problem Description:*
The bottom edge of the reflecting surface of the mirror in the restroom is greater than 40 inches above the finished floor.

• *Mitigation Status:*
Compliant
 • *Date of Repair:*
 2015

- *Original Solution:*
Lower the mirror in the restroom so that the bottom edge of the reflecting surface is no higher than 40 inches above the finished floor and the topmost portion of the reflecting surface extends at least 74 inches above the finished floor (see ADAAG A4.19.6). A single, full-length mirror is recommended since it can accommodate all people. Make certain to provide a minimum clear floor space in front of the mirror of 30 inches in width and 48 inches in length.

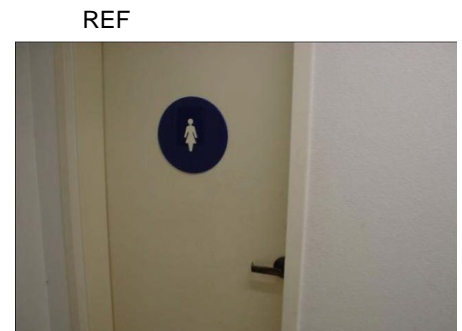
Women's Restroom

- *SSA As-Built Description:*
Entrance to wheelchair accessible toilet or bathing facility not identified with the International Symbol of Accessibility when not all are accessible.
- *SSA Proposed Solution:*
Provide sanitary facility sign that shows the international symbol.

- *Original Problem Description:*
There is no signage indicating accessibility on the latch side of the entry door of the restroom.

• *Mitigation Status:*
Compliant
 • *Date of Repair:*
 N/A

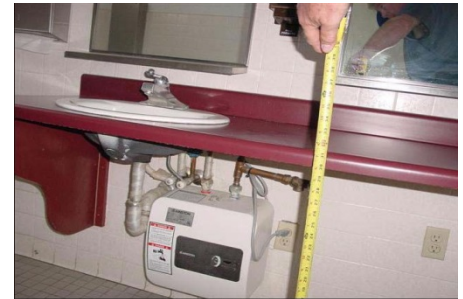
Women's Restroom

• *Original Problem Description:*
The hot water heater under the sink reduces the clear floor space needed for a forward approach.

• *Mitigation Status:*
Compliant
• *Date of Repair:*
2015

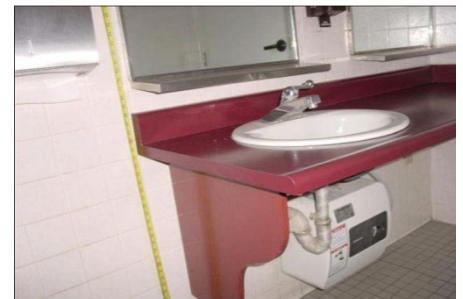
Women's Restroom

• *Original Problem Description:*
The height of the controls and operating mechanisms for the soap dispenser in the restroom is greater than 40 inches in height.

• *Mitigation Status:*
Compliant
• *Date of Repair:*
N/A

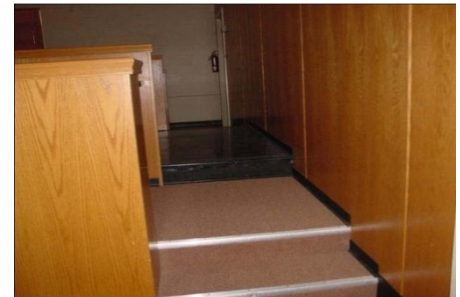
Raised Platform

- *Original Problem Description:*
There is stair access only to the raised platform preventing access to individuals with mobility impairments.

• *Mitigation Status:*
Compliant
• *Date of Repair:*
2015

- *Original Solution:*
Since programs, services and activities may be provided in this location, those programs, services and activities are required to be made accessible. It is recommended that a ramp be installed or other means of vertical access.

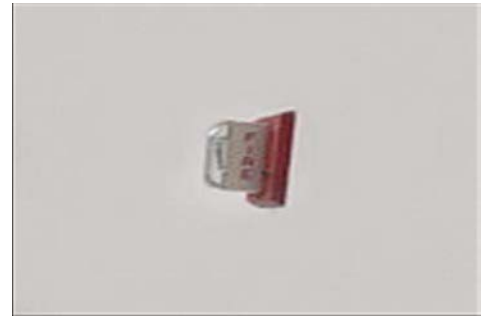
34 Woman's Restroom

Water Closet

• *SSA Proposed Solution:*
Replace flush control with properly mounted accessible type, or install sensor flush.

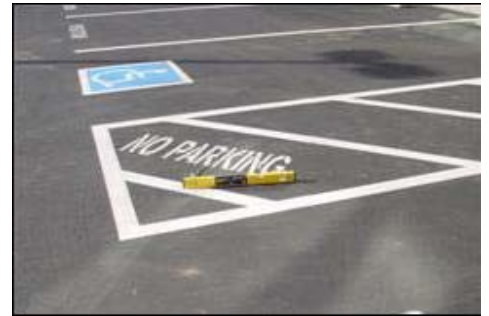
104 Accessible Parking

• *SSA As-Built Description:*
Sign for accessible parking space is missing or non-compliant.

• *Mitigation Status:*
Compliant
• *Date of Repair:*
2012

• *Original Solution:*
Modify the height or replace the post-mounted signage designating the accessible parking space to provide at least 80 inches from the parking space finished grade to the bottom edge of the sign. The sign shall be located so that it cannot be obscured by a vehicle parked in the space (see CBC 1129B.5).

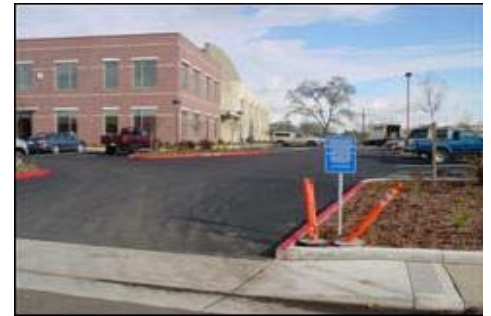
There is warning signage posted at the entrances from Laguna Palms Way and Office Park Circle regarding unauthorized use of accessible parking spaces in the parking lot, though the blank spaces which should furnish the point of contact and telephone number for reclaiming towed vehicles have been left blank.

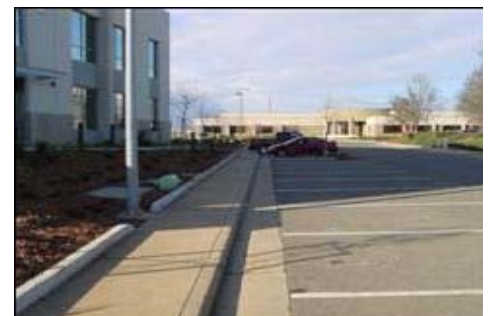
There is no device at the head of the general parking spaces along the east side of the building (off of Office Park Drive) to prevent vehicles from encroaching into the minimum width of the accessible walkway.

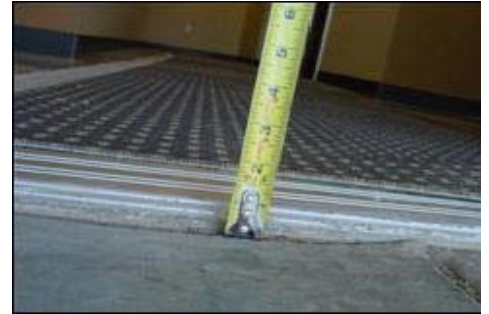
122 Counter at Main Entrance

• *Original Problem Description:*
The main entrance reception counter was inspected and found to comply with height and length requirements.

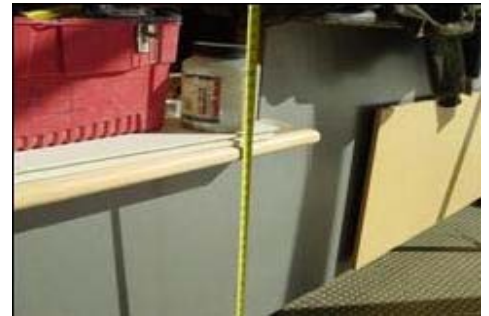
124 Counter in Building Department

- *Original Problem Description:*
The planning/building/public reception counter was inspected and was found to comply with height and length requirements.

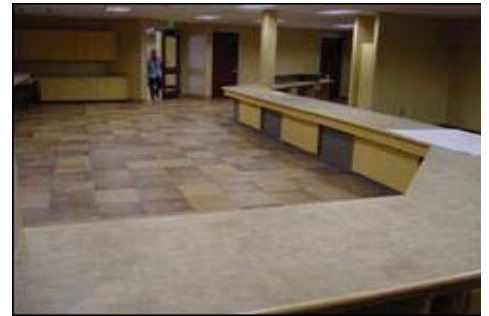
- *Original Problem Description:*
The reception counter was inspected and was found to comply with height and length requirements..

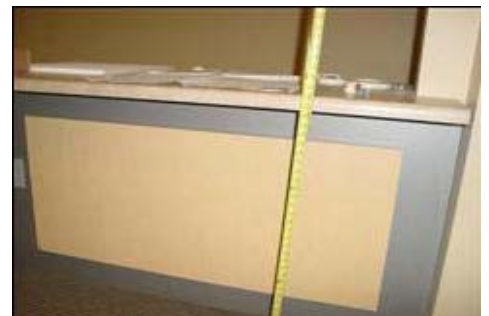
- *Original Problem Description:*
The public works reception counter was inspected and was found to comply with height and length requirements.

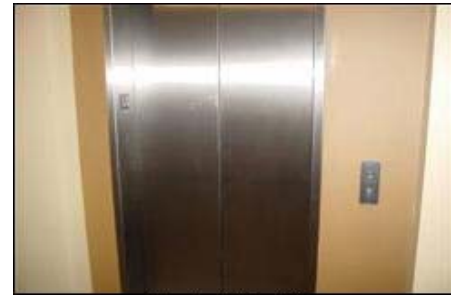
Elevator in Main Lobby

• *Original Problem Description:*
There is an elevator. There is no Title 19 tactile emergency evacuation signage provided at the elevator.

• *Original Solution:*
The elevator must be certified and found to be compliant with CBC and ADAAG guidelines as directed by the State of California, Division of the State Architect, Office of Regulation Services, to provide accessibility to programs, services and activities at different levels of the facility. Make certain that the elevator is operational and available for individuals with mobility impairments during all hours the facility is open.

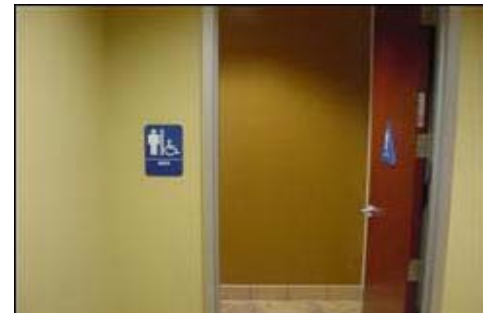
• *Original Problem Description:*
There is signage indicating accessibility on the entry door to the restroom. The signage is centered 60 inches above the floor on the latch side of the entrance door and includes Braille and raised lettering, gender use symbol and the ISA symbol.

• *Original Solution:*
The restroom is designated accessible and should be made an accessible restroom for the facility. Monitor signage for continued compliance with CBC 1115B.5, ADAAG 4.1.2(7) and ADAAG 4.1.6(3)(e) and ADAAG 4.30.

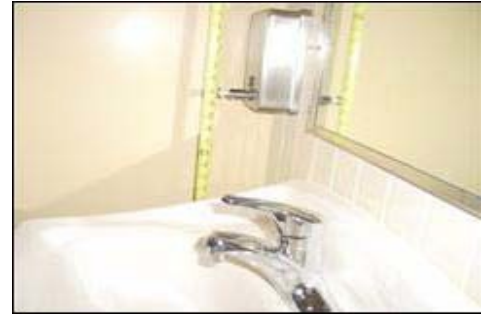
• *Original Problem Description:*
 The height of the controls and operating mechanisms for the soap dispenser in the restroom is 40 5/8 inches in height.

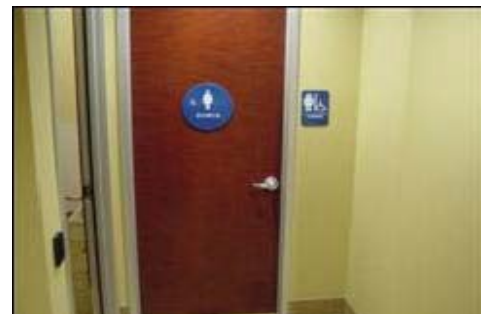
• *Original Problem Description:*
 There is signage indicating accessibility on the entry door to the restroom. The signage is centered 60 inches above the floor on the latch side of the entrance door and includes Braille and raised lettering, gender use symbol and the ISA symbol.

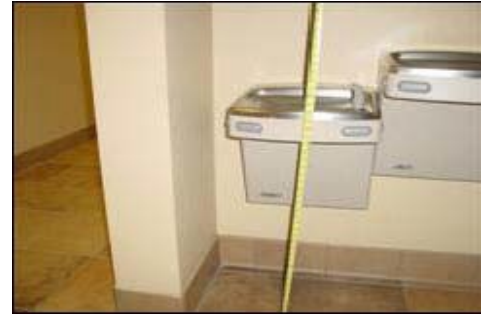
• *Original Problem Description:*
All drinking fountains were found to comply with CBC and ADAAG requirements.

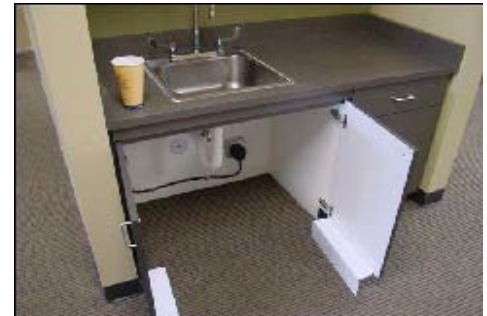
The counter sinks at the facility were inspected and found to be accessible.

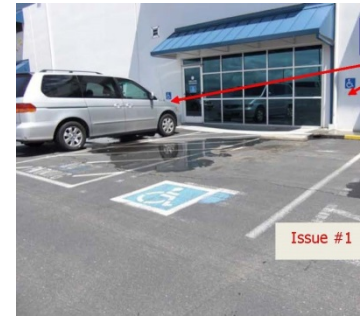
Priority 1
Severity 2

- *Original Problem Description:*
The old accessible parking area still shows access aisles not required, and 36" x 36" ISA symbols are still showing on the ground. There are many lines faded, and there is a very faded ISA symbol showing through the word "visitor" in a visitor parking stall.
- *Original Solution:*
This area should be resurfaced with a black coating; this could be a slurry seal or similar process. Old access aisles that are no longer required will be blacked out.

Recommendation: Ensure other accessible stalls are provided close to the nearest possible entrance on an accessible route; area to be resurfaced and repainted as regular stalls.

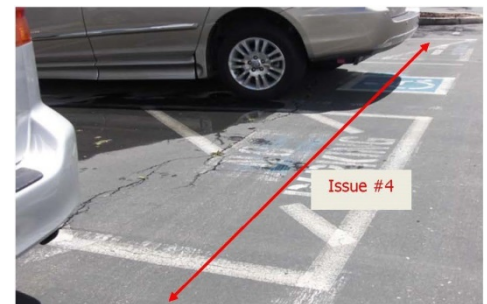
- *Original Problem Description:*
At the top and bottom of the current accessible parking spaces there is a slope exceeding the allowed 2%.

- *Original Solution:*
All accessible spaces and access aisle needs to be resurfaced with slopes and cross slopes less than 2%. The access aisle shall be marked by a blue border. Within the blue border, hatched lines shall be painted a color contrasting with the parking surface, preferably blue or white. The State DSA recommends white on asphalt, blue on concrete. CBC Section 1129B.3.1 & .2

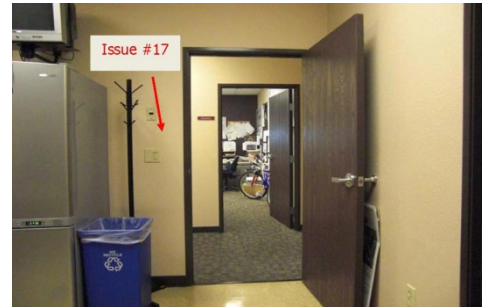
- *Original Problem Description:*
There is no tactile "EXIT ROUTE" sign on the wall inside the 2nd Break room on the latch side of the door.

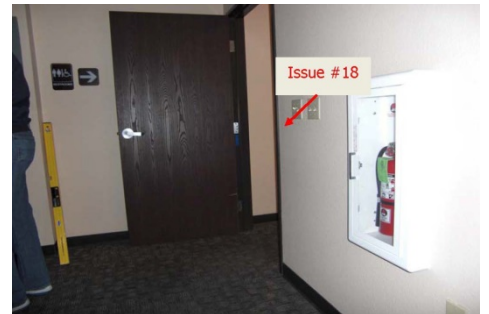
- *Original Problem Description:*
There is no tactile "EXIT ROUTE" sign on the wall adjacent to the strike edge of the door leading to the 2nd Floor Restrooms to the left of the Fire Extinguisher.

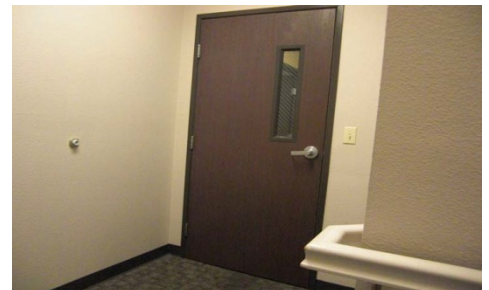
- *Original Problem Description:*
In the enclosed stairways there is no tactile stair level identification sign located at each floor level landing.

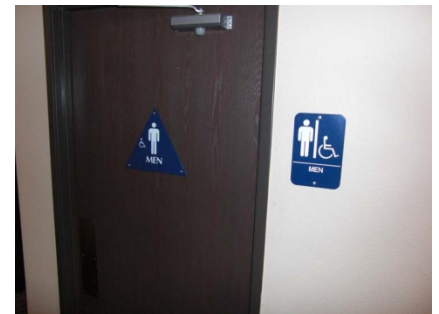
- *Original Problem Description:*
Clear space and level area does not extend 24" past the strike edge of door on the inside of the room.

- *Original Solution:*
Recommend swapping doors from men's restroom with the women's restroom which changes the swing of the door so that the side to which the door swings extends 24 inches. CBC 1133B.2.4.3

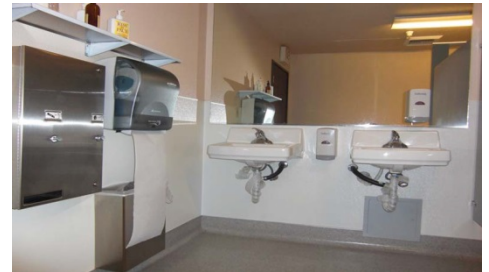
• *Original Problem Description:*
 Soap dispenser on right is mounted to the surface of the mirror and is more than 40" AFF.

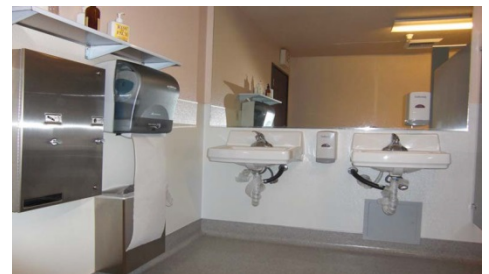
• *Original Problem Description:*
 The wrapping on the pipes below the sinks is loose and needs rewrapping.

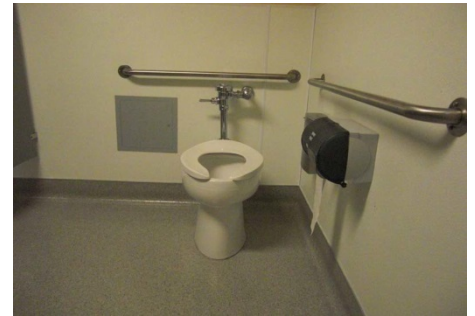
- *Original Problem Description:*
The rear grab bar in the accessible toilet compartment is not mounted with 12" on one side from the centerline of the toilet and 24" on the wide side of the toilet.

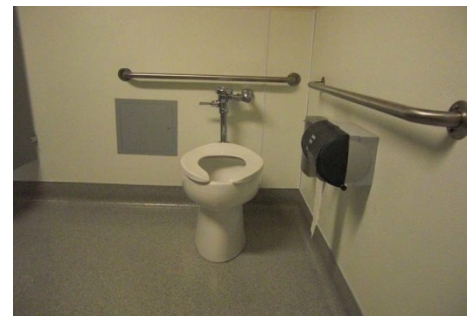
- *Original Problem Description:*
The far edge of the toilet tissue dispenser from the rear wall is at 41" and should be no more than 36" maximum.

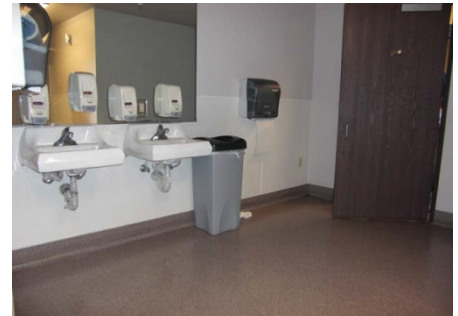
- *SSA As-Built Description:*
Refer to notes for observation and recommendation.
- *SSA Proposed Solution:*
Code references door shall not swing into any clear floor space for a fixture, not accessory.

- *Original Problem Description:*
Entry door swings into the clear space required for the paper towel dispenser.

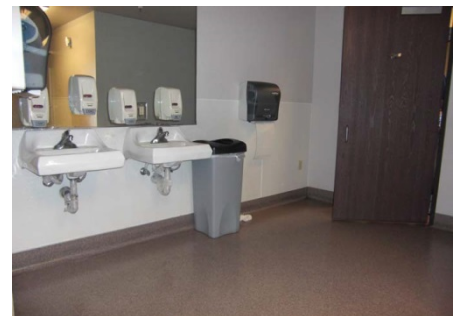
- *Original Problem Description:*
All four soap dispensers are mounted directly on the mirror, not only obstructing view of someone using a wheelchair but also higher than 40" from the finished floor to the activating button.

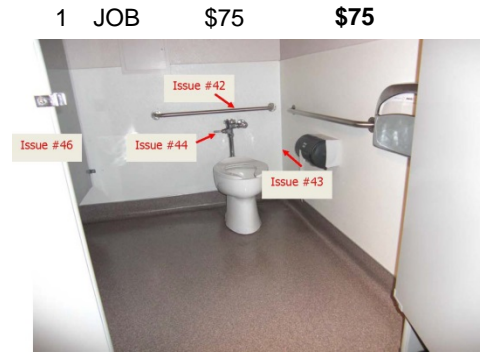
- *Original Problem Description:*
The far edge of the toilet tissue dispenser from the rear wall is at 41" and should be no more than 36" maximum.

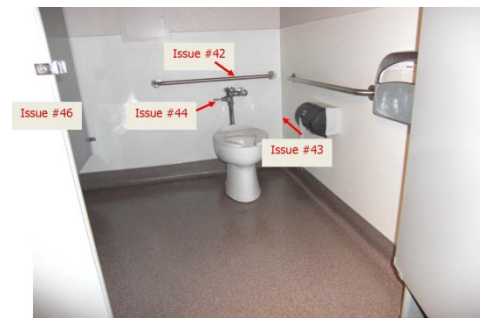
- *SSA As-Built Description:*
Flush Control: Operating handle requires more than 5 lbs force to operate.
- *SSA Proposed Solution:*
Replace flush control with properly mounted accessible type, or install sensor flush.

- *Original Problem Description:*
Flush control on the toilet in the accessible toilet compartment requires 8 lbs of force (lbf) to activate.

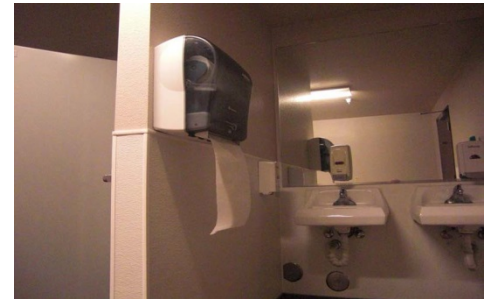
• *Original Problem Description:*
 Activator on the towel dispenser is located at 49 1/2" above the finished floor (AFF) and should be no higher than 40" AFF.

• *SSA Proposed Solution:*
 Provide a recessed unit as it poses as a protrusion hazard and ensure operable part of dispenser is installed at 40" max.

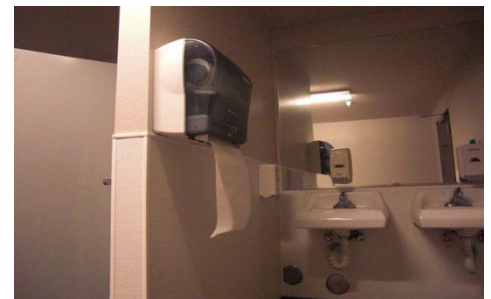
• *Original Problem Description:*
 Two soap dispensers are mounted directly on the mirror, not only obstructing view of someone using a wheelchair but also higher than 40" from the finished floor to the activating button.

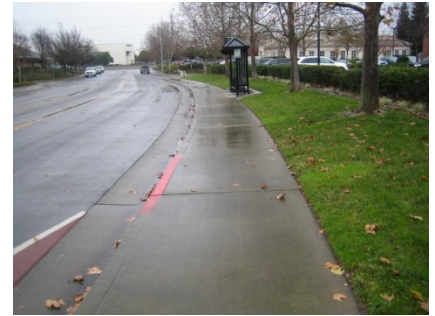
• *SSA As-Built Description:*
Cross slope more than 1/4":12" (2%).

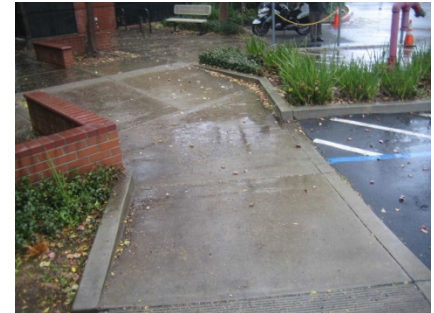
Item No. and Name	Existing Architectural Barrier and Proposed Solution	Codes / Mitigation Info	Qty	Unit	Cost	Total
Curb Ramp	<ul style="list-style-type: none"> • <i>SSA As-Built Description:</i> Detectable warning not provided where pedestrian crosses vehicular area. • <i>SSA Proposed Solution:</i> Provide detectable warning surface (i.e. in-line truncated domes) at regular curb ramp. 	ADAAG 4.7.7 ADA 2010 705.1 Priority 1 Severity 3	1	JOB	\$250	\$250
	<ul style="list-style-type: none"> • <i>Original Problem Description:</i> • <i>Original Solution:</i> 	<ul style="list-style-type: none"> • <i>Mitigation Status:</i> Non-Compliant • <i>Date of Repair:</i> N/A

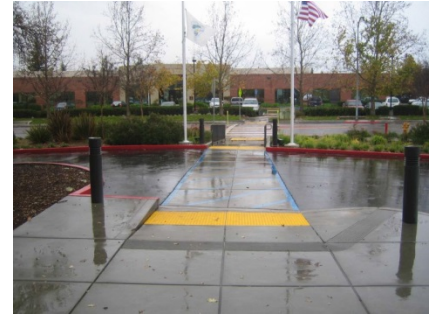
3 Curb Ramp Adjacent to Employee Entrance on West Side of Building
